# **Documented Stormwater Runoff Beyond Arizona Snow Bowl's Permit Area Causes Erosion and Pollution of Hart Prairie's Ecosystem**

**by  
Richard Hereford\*, Tom Brownold, and Gwendolyn  
Waring Flagstaff, Arizona**

*Presented at the  
Sacred Mountain Ecological and Historical Update  
Flagstaff, Arizona  
August 19, 2022*

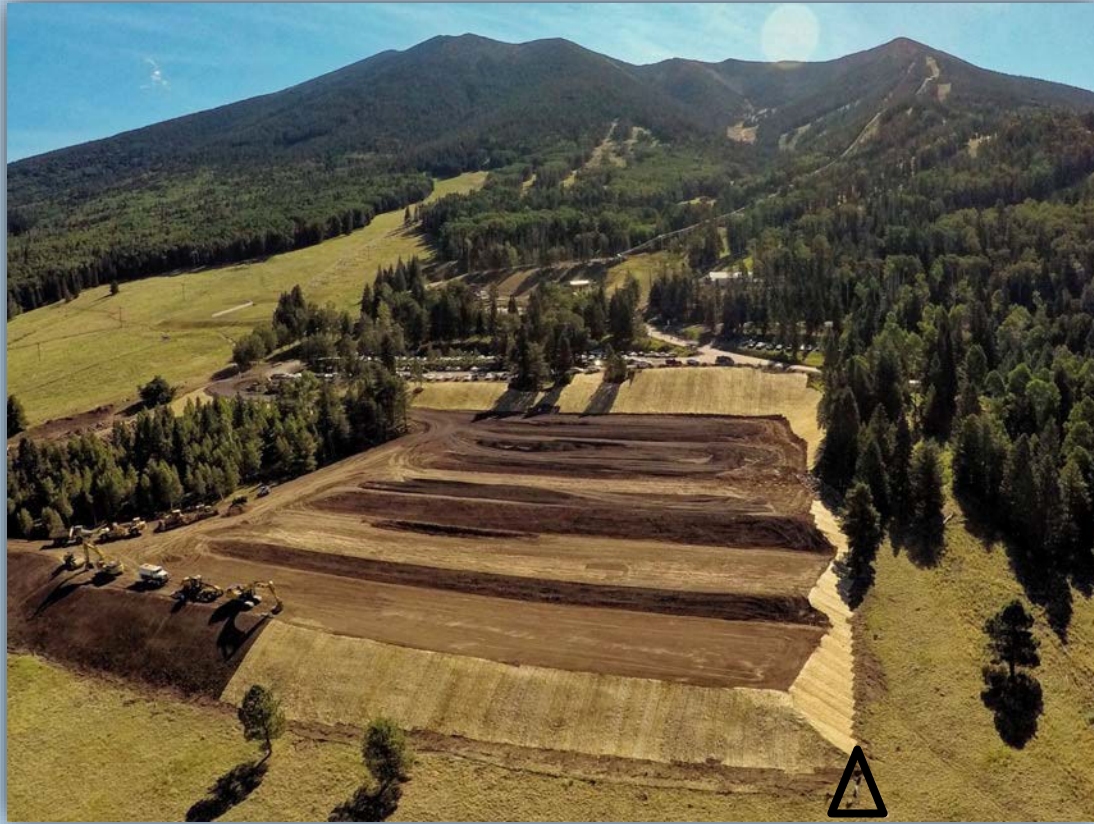
*Arizona Snow Bowl's new parking lot under construction on Hart Prairie, summer 2020. Realignment of stormwater drainage system has exacerbated existing runoff problems on the prairie. Triangle is cadastral corner monument marking southwestern boundary of Arizona Snow Bowl's Special Permit Use Area.*

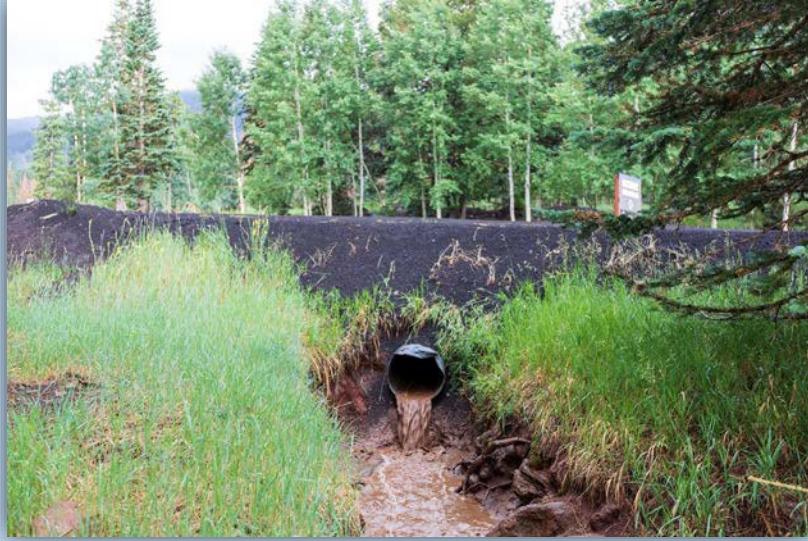
*Drainage culvert flowing into previously eroded gully on Hart Prairie, July 18, 2021 around 4 pm. Culvert passes under Forest Road 516. Water quality samples were collected here just outside of Snow Bowl's permit area.*

- Preliminary discharge rates of the July 18 2021 runoff are 9.5 and 21.7 cubic feet second (cfs) as estimated from two floodlines in this culvert. The stormwater system drains the one-square-mile Snow Bowl drainage basin, which has 3,040 feet of vertical relief. Given the high relief and small size, basin runoff can be substantial.

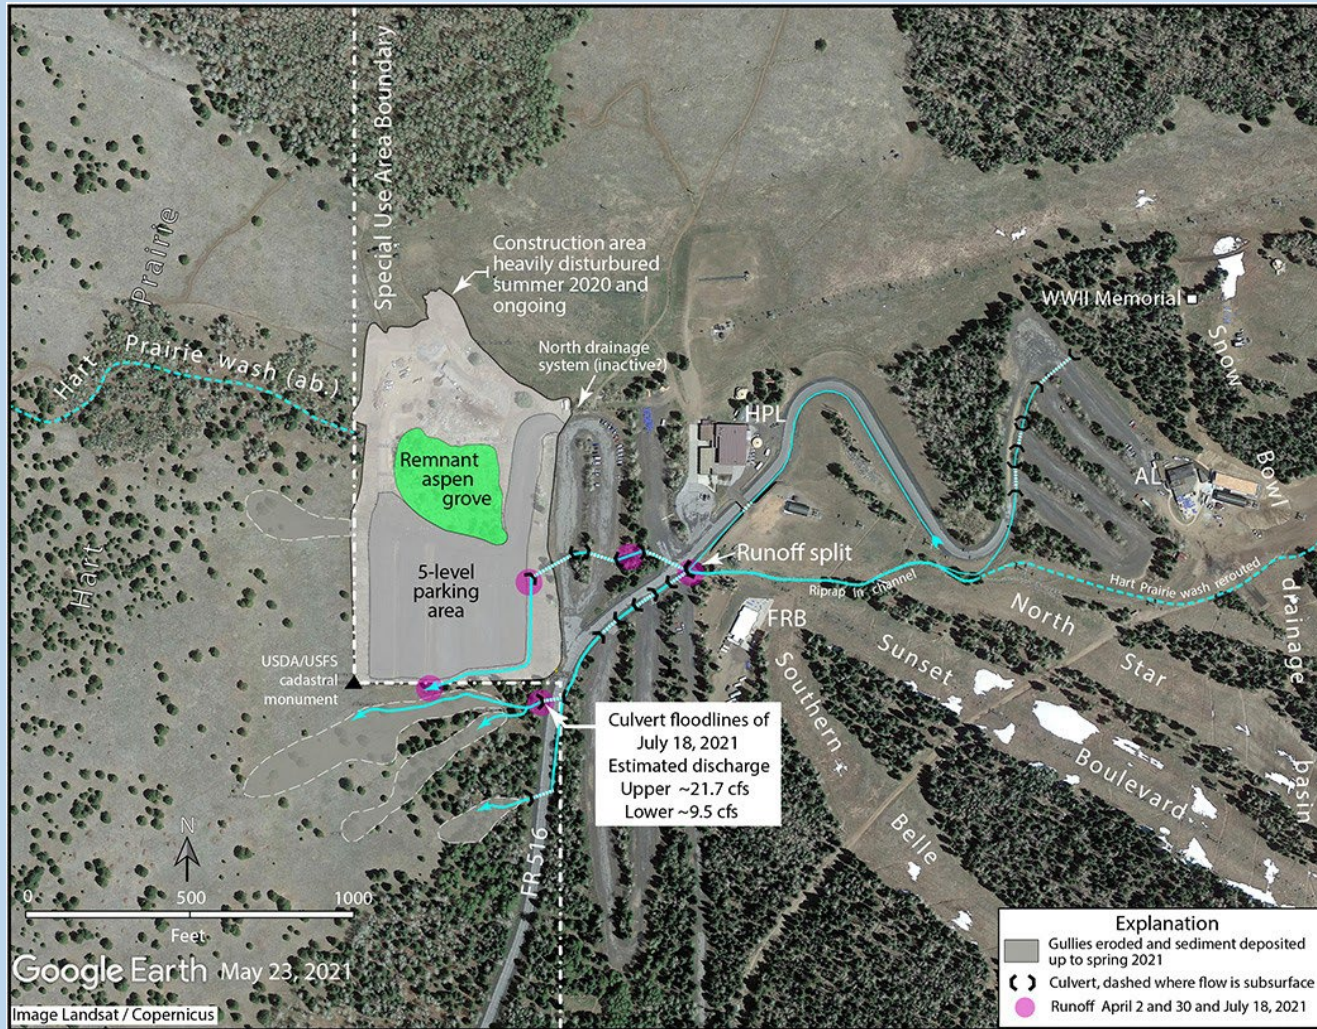
Map of Snow Bowl facilities showing the lower Snow Bowl drainage basin, upper Hart Prairie, the problematic stormwater drainage system (open channel and culvert symbols), and Snow Bowl's parking and visitor facilities.

- Development of Snow Bowl's parking lots between 1976–92 blocked the historical course of Hart Prairie wash, which was abandoned and replaced by a stormwater drainage system (see ADDENDUM).

- Runoff from the entire drainage basin enters the stormwater system at the runoff split. A substantial portion of stormwater originates on numerous ski slopes treated with nutrient-rich reclaimed water used in snowmaking since 2012.

- Below the split, runoff is redistributed to the south end of the new parking lot and southwest along FR 516. Where they terminate, only 320 feet separates them, which doubles runoff and concentrates it over a larger area of Hart Prairie.

- The July 18, 2021 runoff was sampled for water quality analysis at the exit of the labeled culvert. It carried an extremely high nutrient load as well as suspended sediment onto Hart Prairie.

- Four light gray patterns map gullies, sediment, and litter from several runoff events mostly after 2011 (if not 2003) and before 2021.

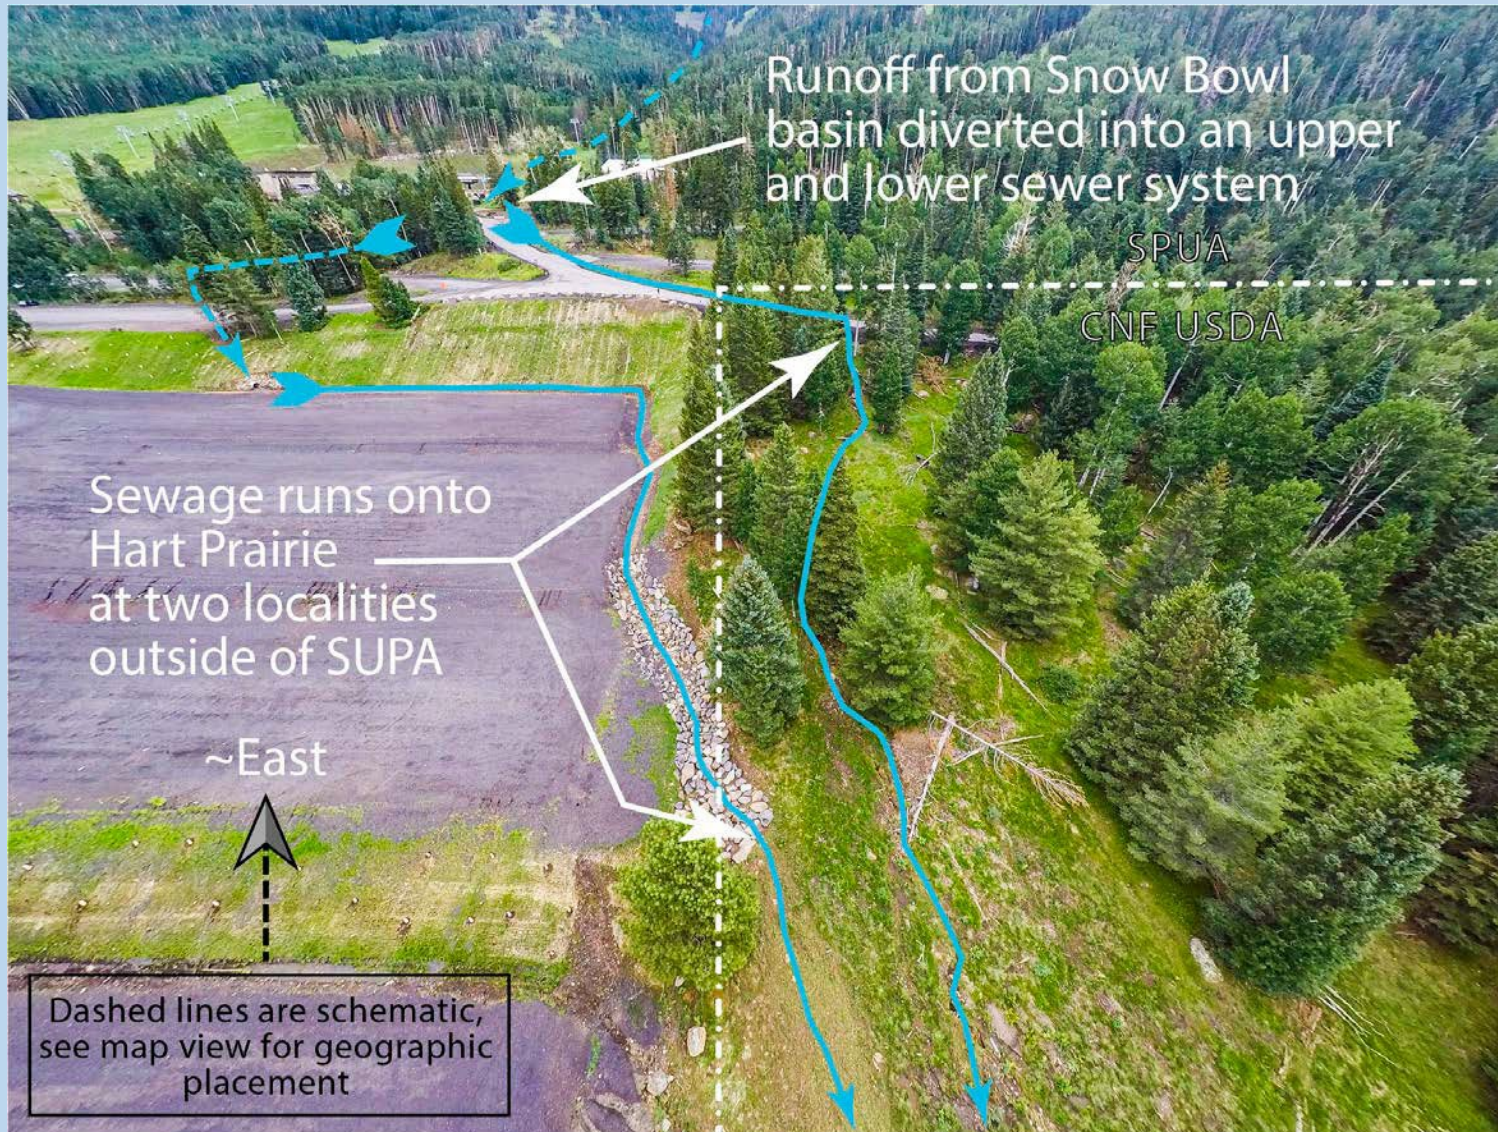
The stormwater drainage carries snowmelt and stormwater runoff from Snow Bowl basin, which covers about one square mile and has 3,040 feet of vertical relief. Runoff was formerly into Hart Prairie wash before the modern development of the Snow Bowl. Physical evidence indicates that the wash historically carried high-volume floods that the basin produced either from snowmelt, rain on snow, or monsoonal rainfall.

- Wastewater runoff is incising gullies on Hart Prairie where none existed, a process that will severely alter the prairie landscape.
- More importantly, initial water quality analysis of the runoff reveals a heavy suspended sediment load and damagingly high nutrient levels. The reported nutrient levels are preliminary, and further research and study are necessary to comprehend runoff water chemistry fully.

*Oblique (distorted) aerial view of the terminal portion of the stormwater drainage system where it debouches onto Hart Prairie.*

**A simple solution to the runoff problem is a retention pond placed within Snow Bowl's permitted area. Indeed, the 2005 FEIS recommends the construction of a retention pond, obviously, this did not happen.**

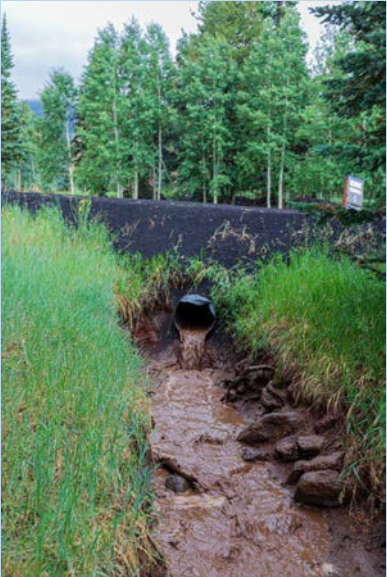
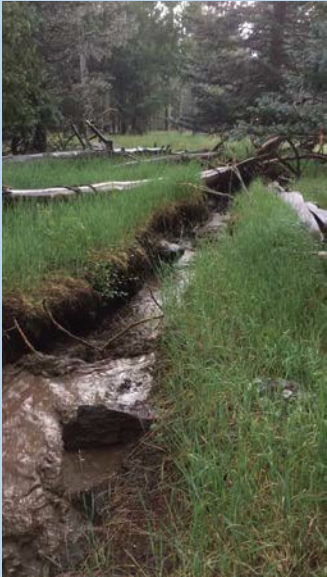
*Top—Left to right, video clips of lower drainage system. Culvert outflow under FR 516 (far left). Waterline in culvert from peak July flow was substantially deeper than flow in this photograph. Downstream view of eroding gully (middle) and view of runoff across prairie (right). All runoff was south of permit boundary, as seen here by south side of parking lot, July 18, 2021. Videos available on request.*

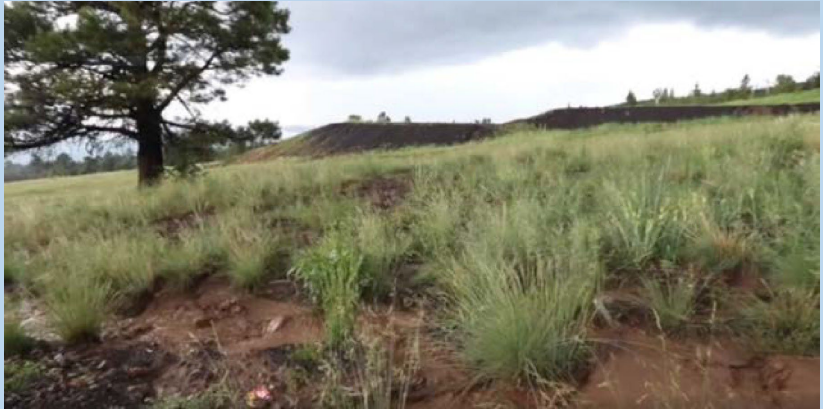
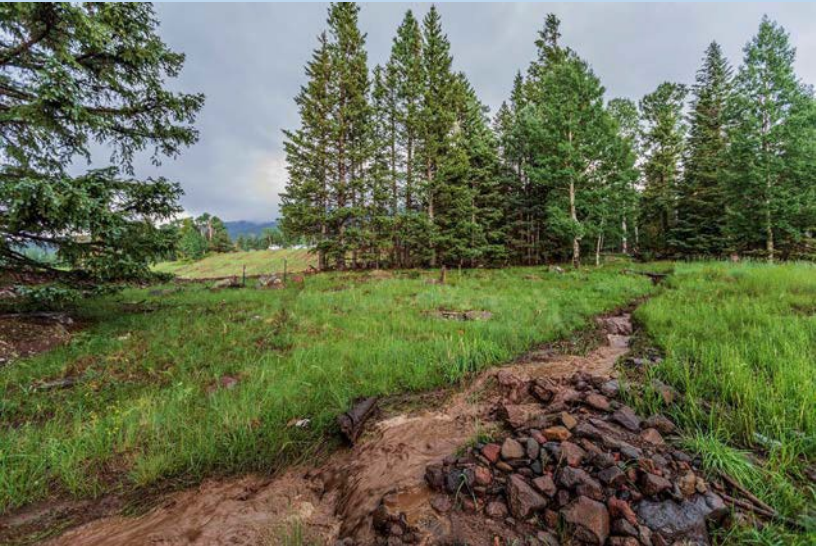
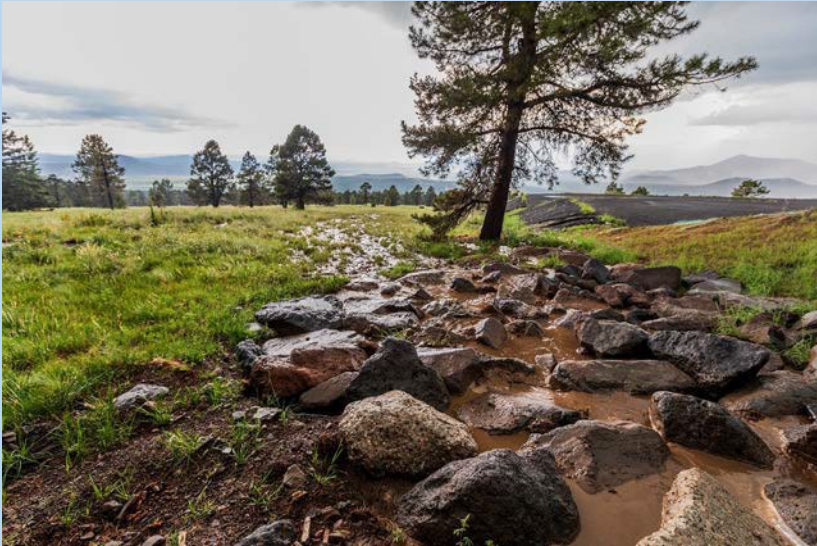
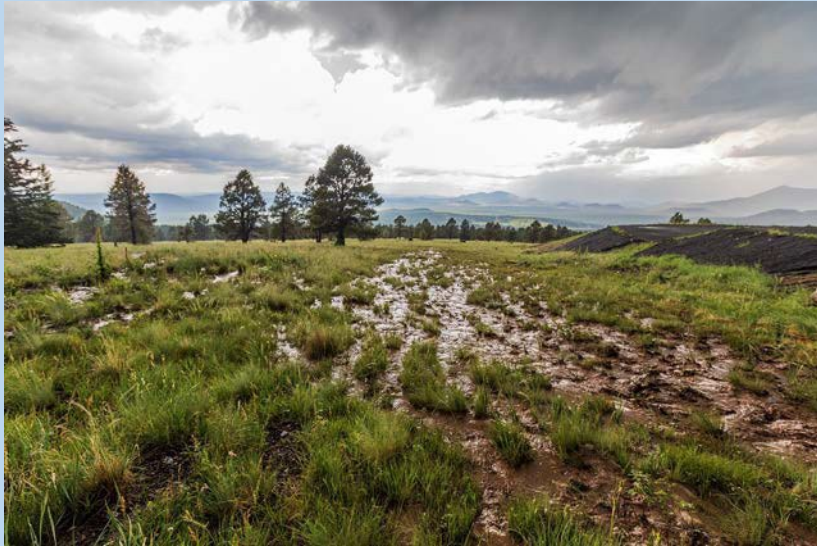
*Bottom—Left to right, upstream view of wastewater from lower drainage culvert onto meadow; downstream view of runoff over riprap at end of upper drainage system onto the prairie; downstream view of runoff near junction of the two drainage segments. Total width of two segments near this point was 180 feet.*

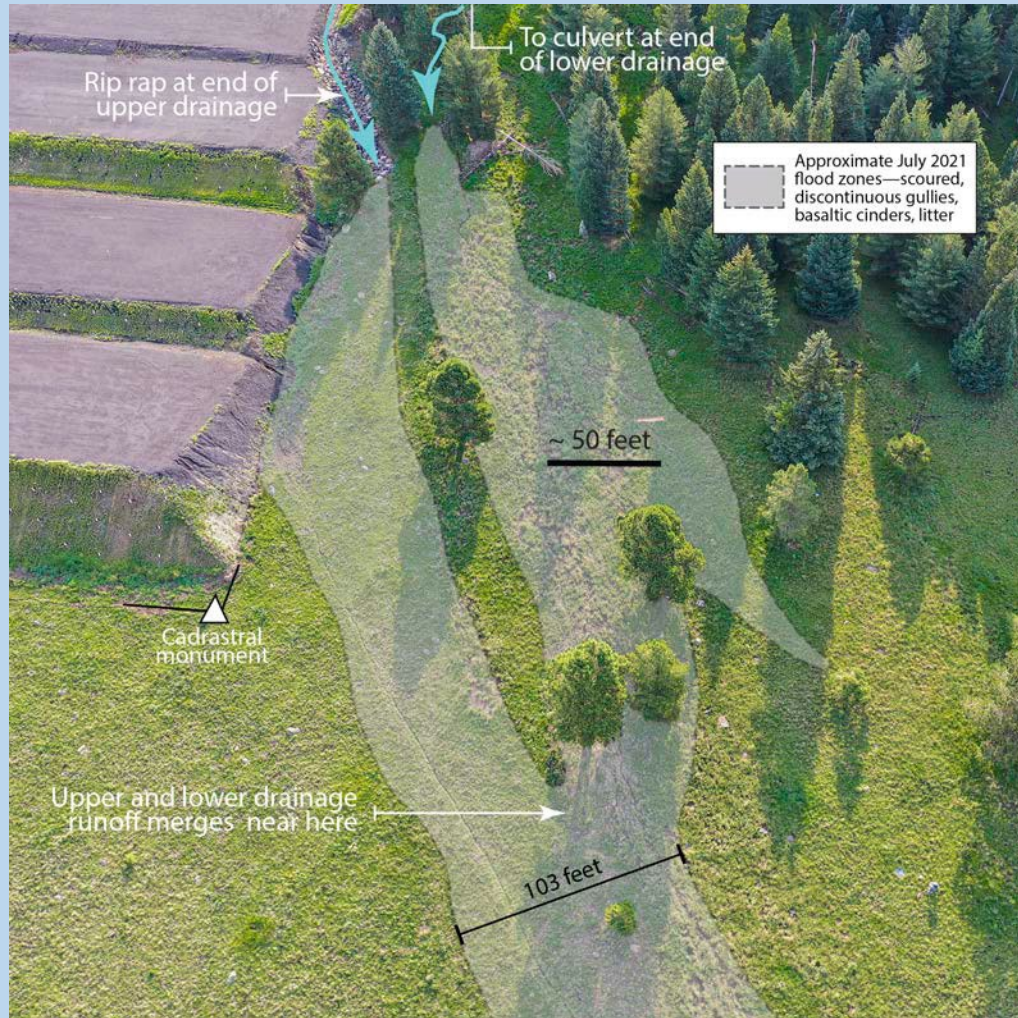
Below—Oblique aerial view of flood scour zone (gray pattern) showing combined runoff of upper and lower drainage segments. Diagnostic features are litter from parking lots and other Snow Bowl facilities: dark basaltic cinders, granular asphaltic debris, and discontinuous gullies. Boundary of permit follows south side of parking lot. Flood zone above split at lone tree is 180 feet wide with 25 feet of separation.

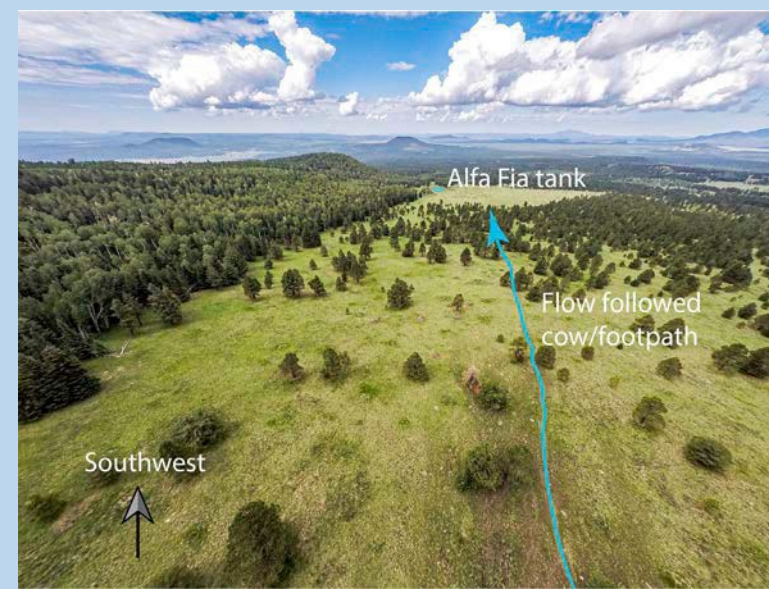
Top—Path of combined wastewater down southwest side of Hart Prairie alluvial fan. Flow ended 2,620 feet southwest of lower system culvert (see ADDENDUM). **Runoff along preexisting tracks, trails (such as here), and roads is a widely recognized precursor of gully incision and arroyo development in the Southwest.**

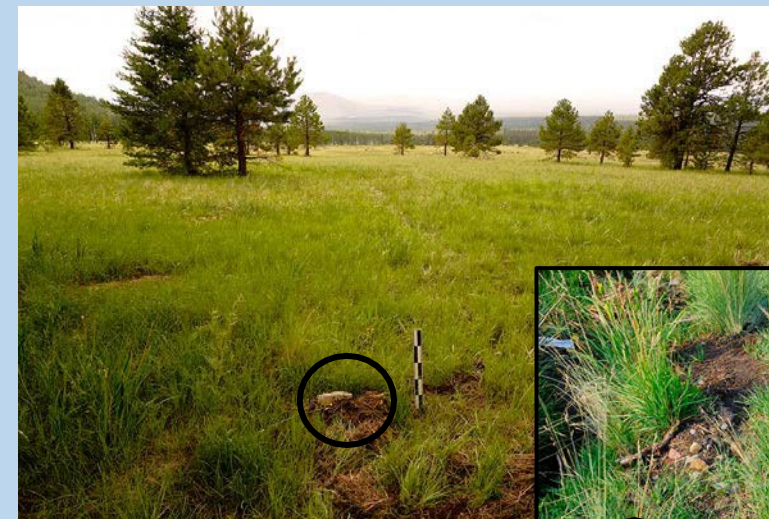
Middle—Flow terminated northeast of Alfa Fia tank. A single plastic water bottle is near scale.

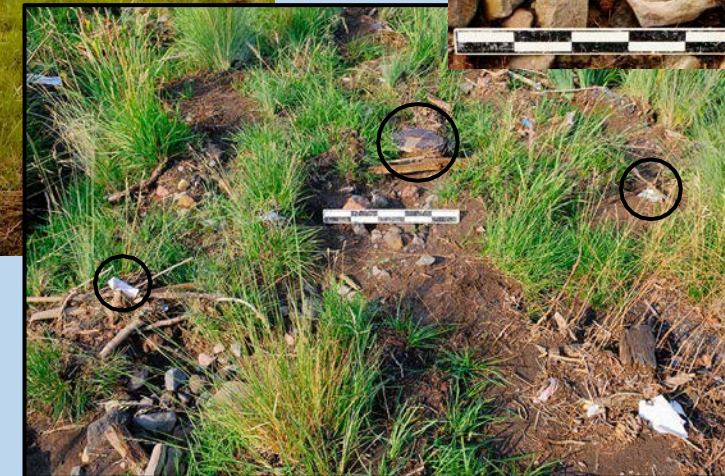
Bottom—Example of litter in runoff consisting of aluminum cans, face mask(s), miscellaneous colored plastic fragments, and various clothing items (circled). Face masks are diagnostic of 2021 runoff. Inset, cobble-size asphaltic clast in gravel.

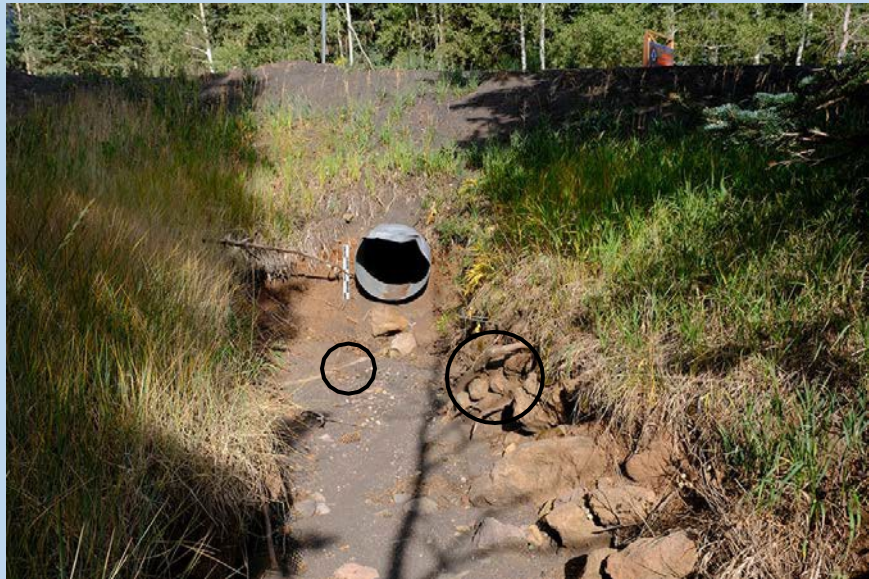
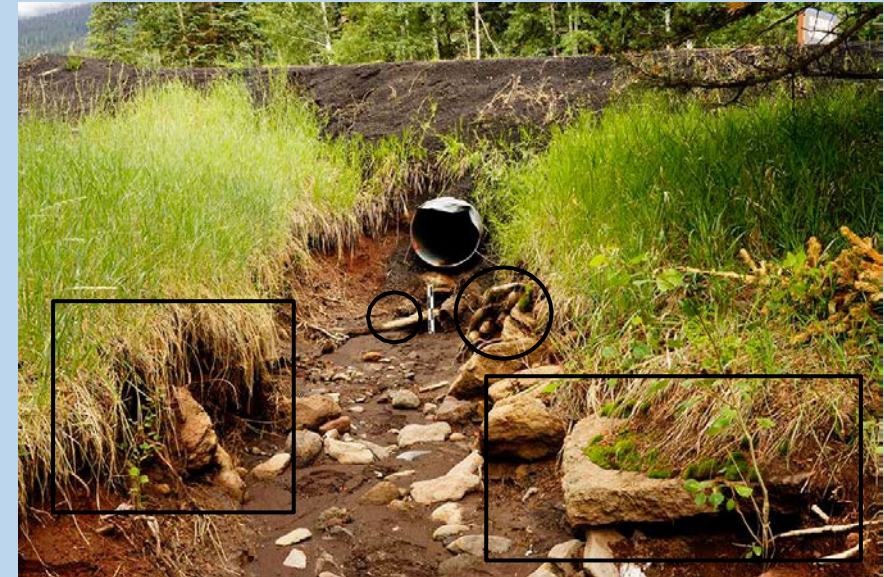
*Upstream views of lower drainage system at and downstream of culvert. Upper left 9/20/2020 upper right 7/27/2021, scale 50 cm long with 10 cm (~4 inches) divisions. Common features are circled. Gully is deeper and substantially wider (rectangles).*

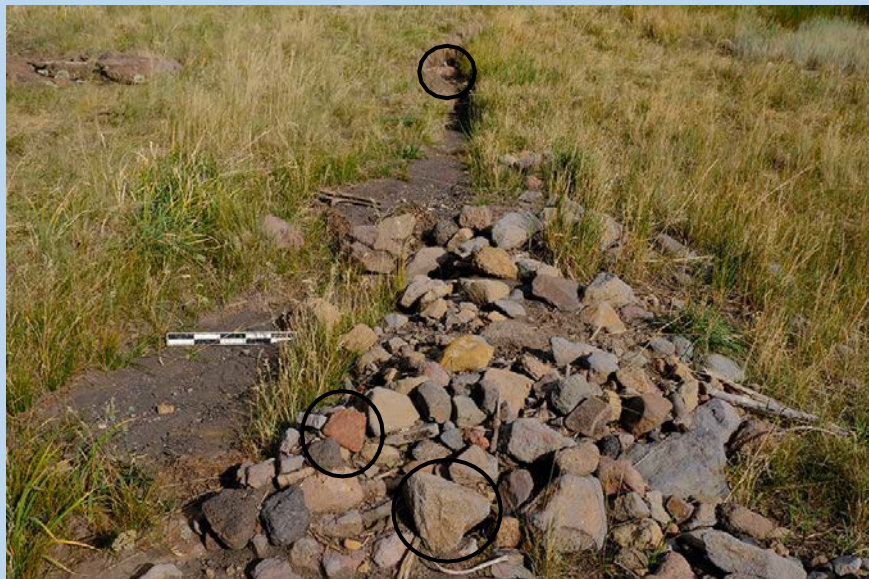
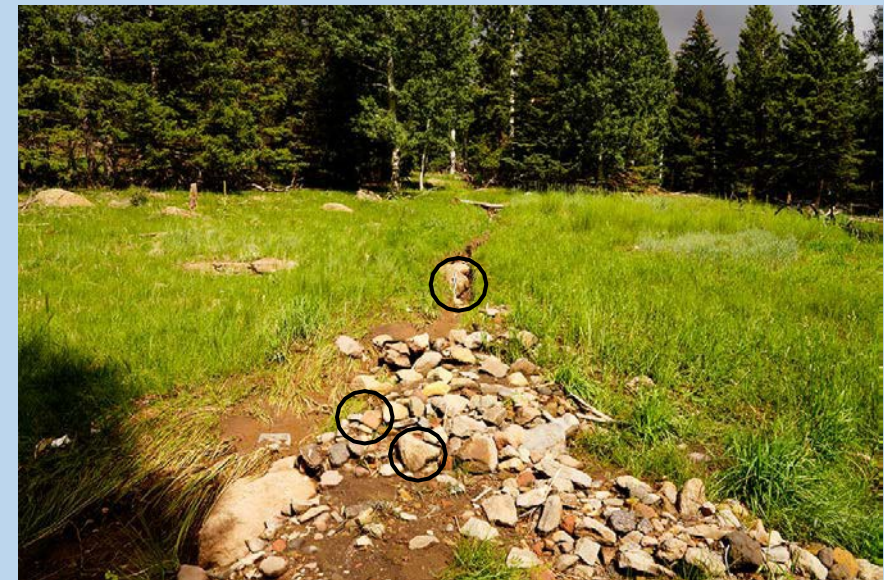
*Lower left and right dates same as above; left—configuration on gravel bar of pebble-size clasts and basaltic cinders (at scale); right—in this wide-angle view of meadow clasts were moved while others moved downstream; gully is wider and deeper particularly at distant scale where gully is more than two feet deep reaching four feet deep at plunge pool farther upstream.*

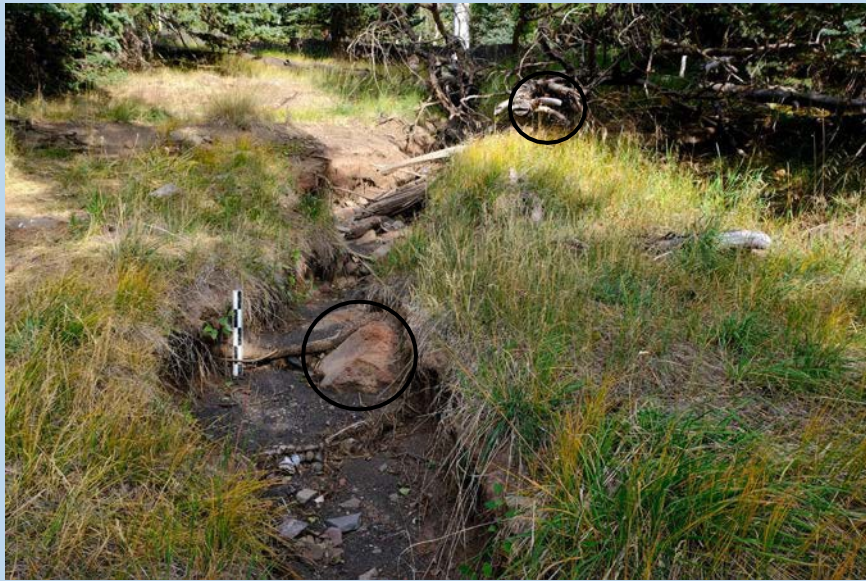
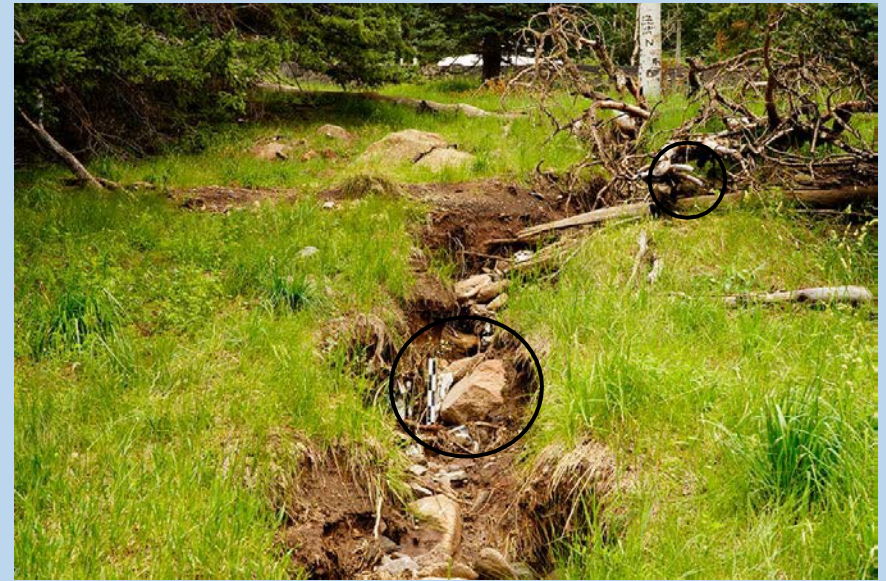
*Upstream view of lower drainage gully—left 9/20/2020, right 7/27/2021. Gully substantially deeper and wider.*

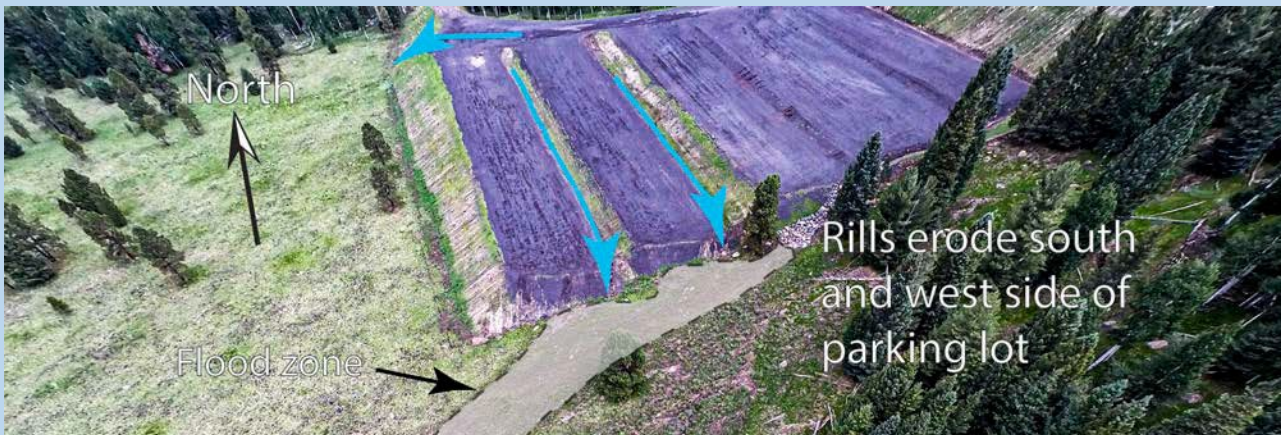
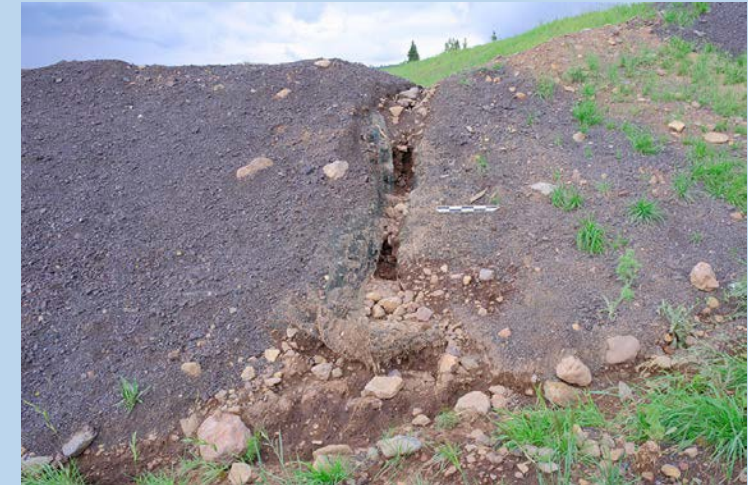
*Left, rills were eroded into south and west-facing sides of parking lot during late July runoff. Right, rill of farthest west of two channels.*

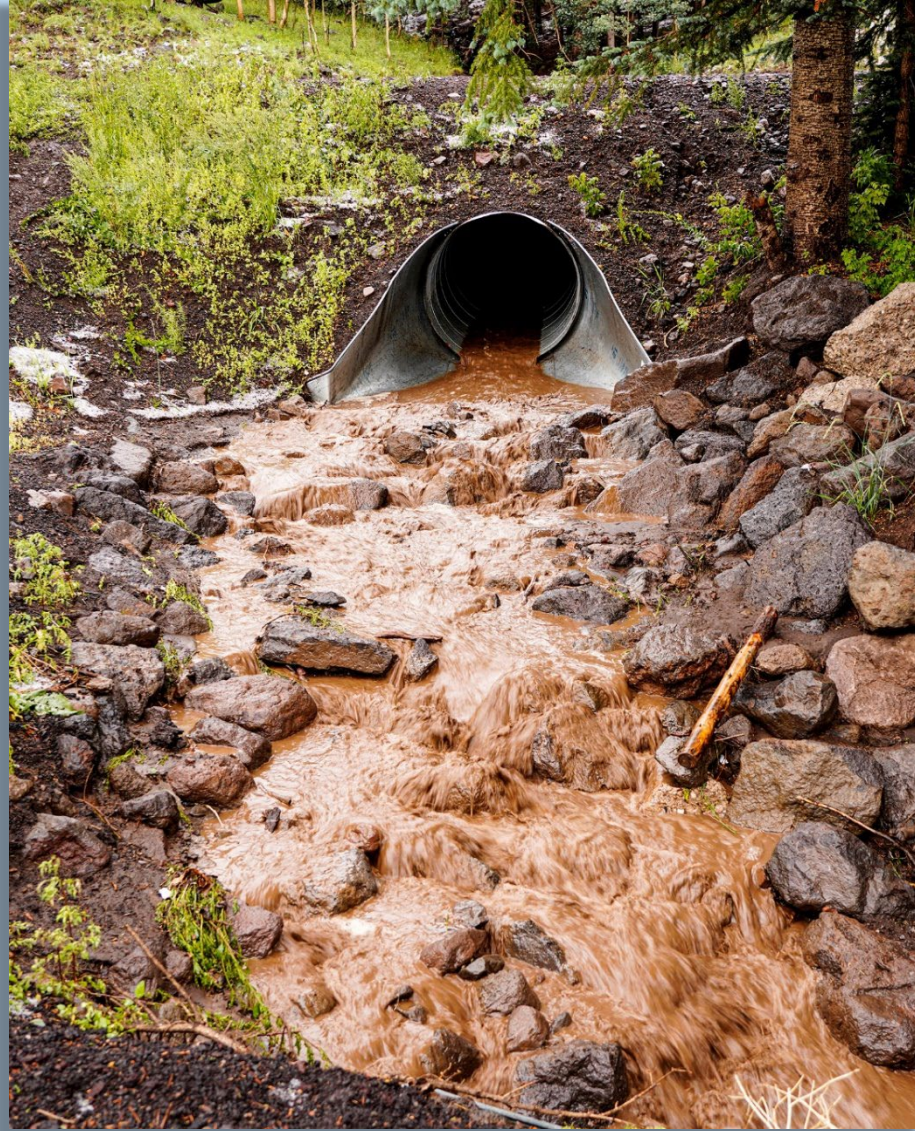
*Left—Turbid, reddish brown runoff of August 14, 2022. The degree of turbidity is partly related to sediment concentration. Right—Continuation of the runoff as it flows in the open channel around the new parking lot and onto Hart Prairie.*

- Sediment concentration of the July 18 runoff was 94,900 mg/L, which is near the lower limit of hyperconcentrated streamflow. This flow was 10 percent suspended sediment by volume.
- High sediment load is a well-known and reliable indicator of channel and hillslope erosion in a drainage basin, which in this case means erosional activity in Snow Bowl drainage basin.
- Ski slopes are the likely source of the suspended sediment as they are easily eroded. The slopes are steep, deforested, and mechanically disturbed.
- Soils on the slopes are eroded during intense rainfall events, shedding sediment-laden runoff downslope into the stormwater drainage system for delivery to Hart Prairie.

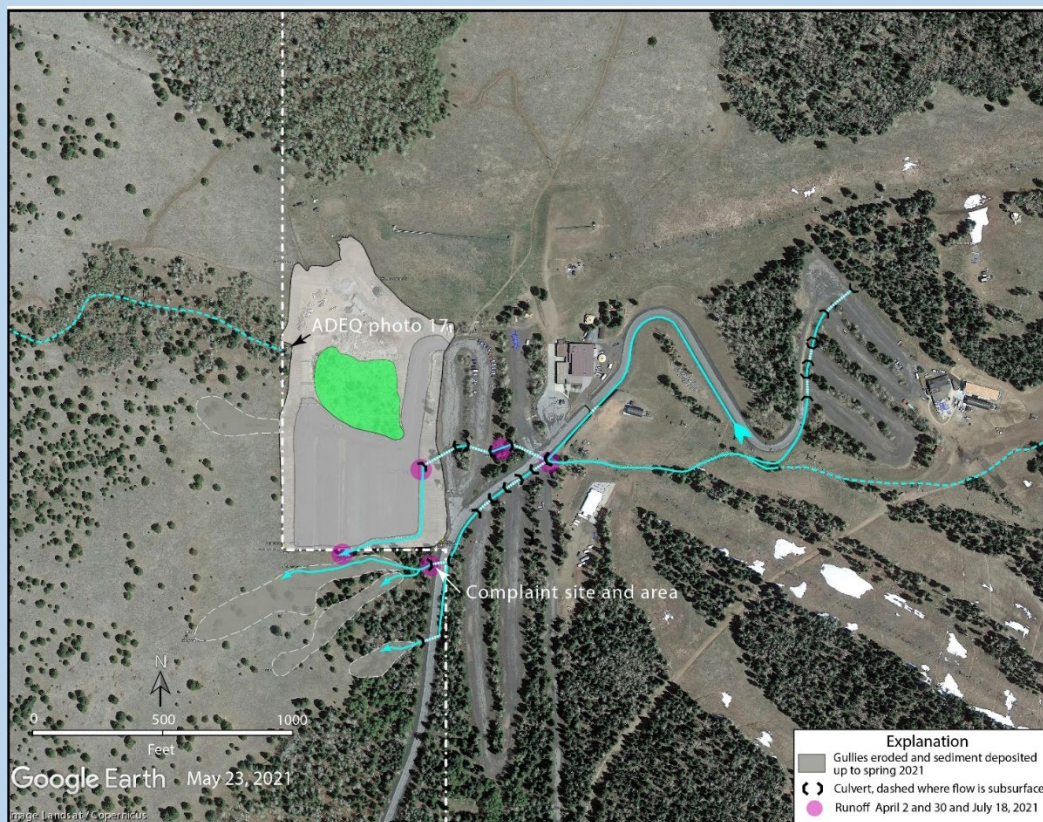
Map focused on Snow Bowl facilities showing the location of ADEQ photo 17, the locus of ADEQ's investigation, and the distant complaint site area. ADEQ team investigated an area approximately north and east of photo 17, which has no hydrological connection to the grievance locality. The complaint site area was not in ADEQ's field of view.

In contrast, the area shown to ADEQ staff by Arizona Snow Bowl management lacks any evidence of surface runoff. Significantly, the grievance site and the investigated site have no surface hydrological connection. These are two completely different surface hydrological situations. Moreover, ADEQ was looking for contaminated snowmelt runoff, whereas runoff in the complaint area is wastewater from monsoon rain falling on the Snow Bowl drainage basin.

This unfortunate situation needs to be corrected. A proper field investigation of the specific complaint site is essential to understand the actual offsite wastewater problem at the Arizona Snow Bowl. **Otherwise, the results of Complaint Inspection #395741 are meaningless.**

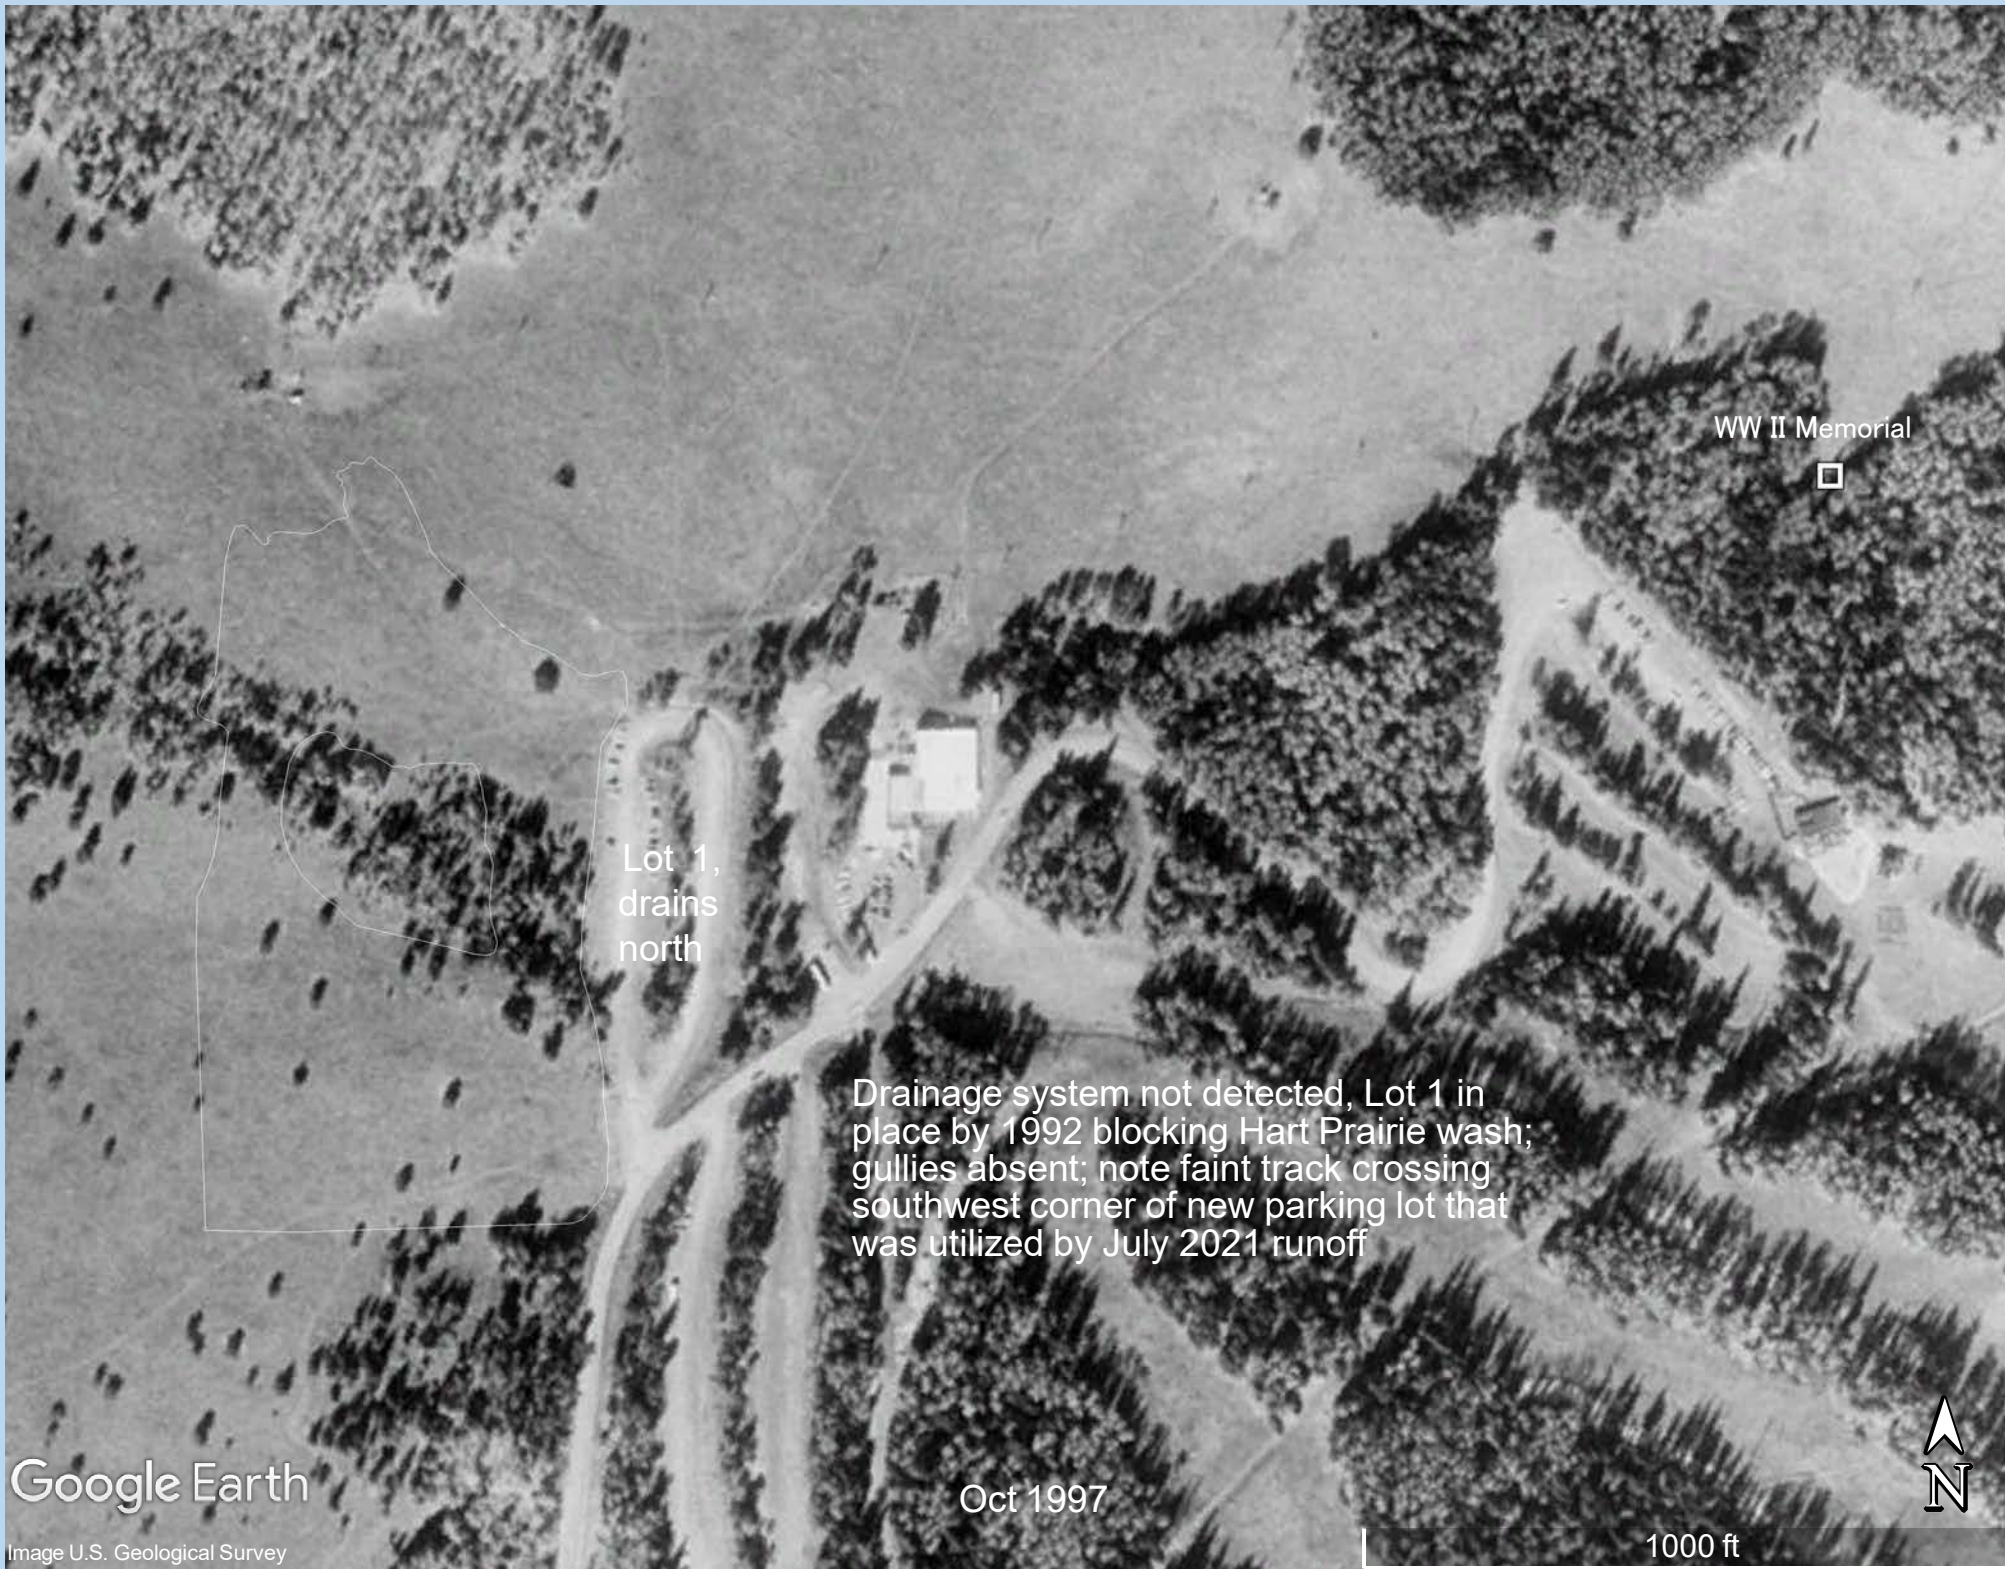
Oct 1997

Drainage system not detected, Lot 1 in place by 1992 blocking Hart Prairie wash; gullies absent; note faint track crossing southwest corner of new parking lot that was utilized by July 2021 runoff
