# **Documented Stormwater Runoff Beyond Arizona Snow Bowl's Permit Area Causes Erosion and Pollution of Hart Prairie's Ecosystem**

**by  
Richard Hereford\*, Tom Brownold, and Gwendolyn  
Waring Flagstaff, Arizona**

*Presented at the  
Sacred Mountain Ecological and Historical Update  
Flagstaff, Arizona  
August 19, 2022*

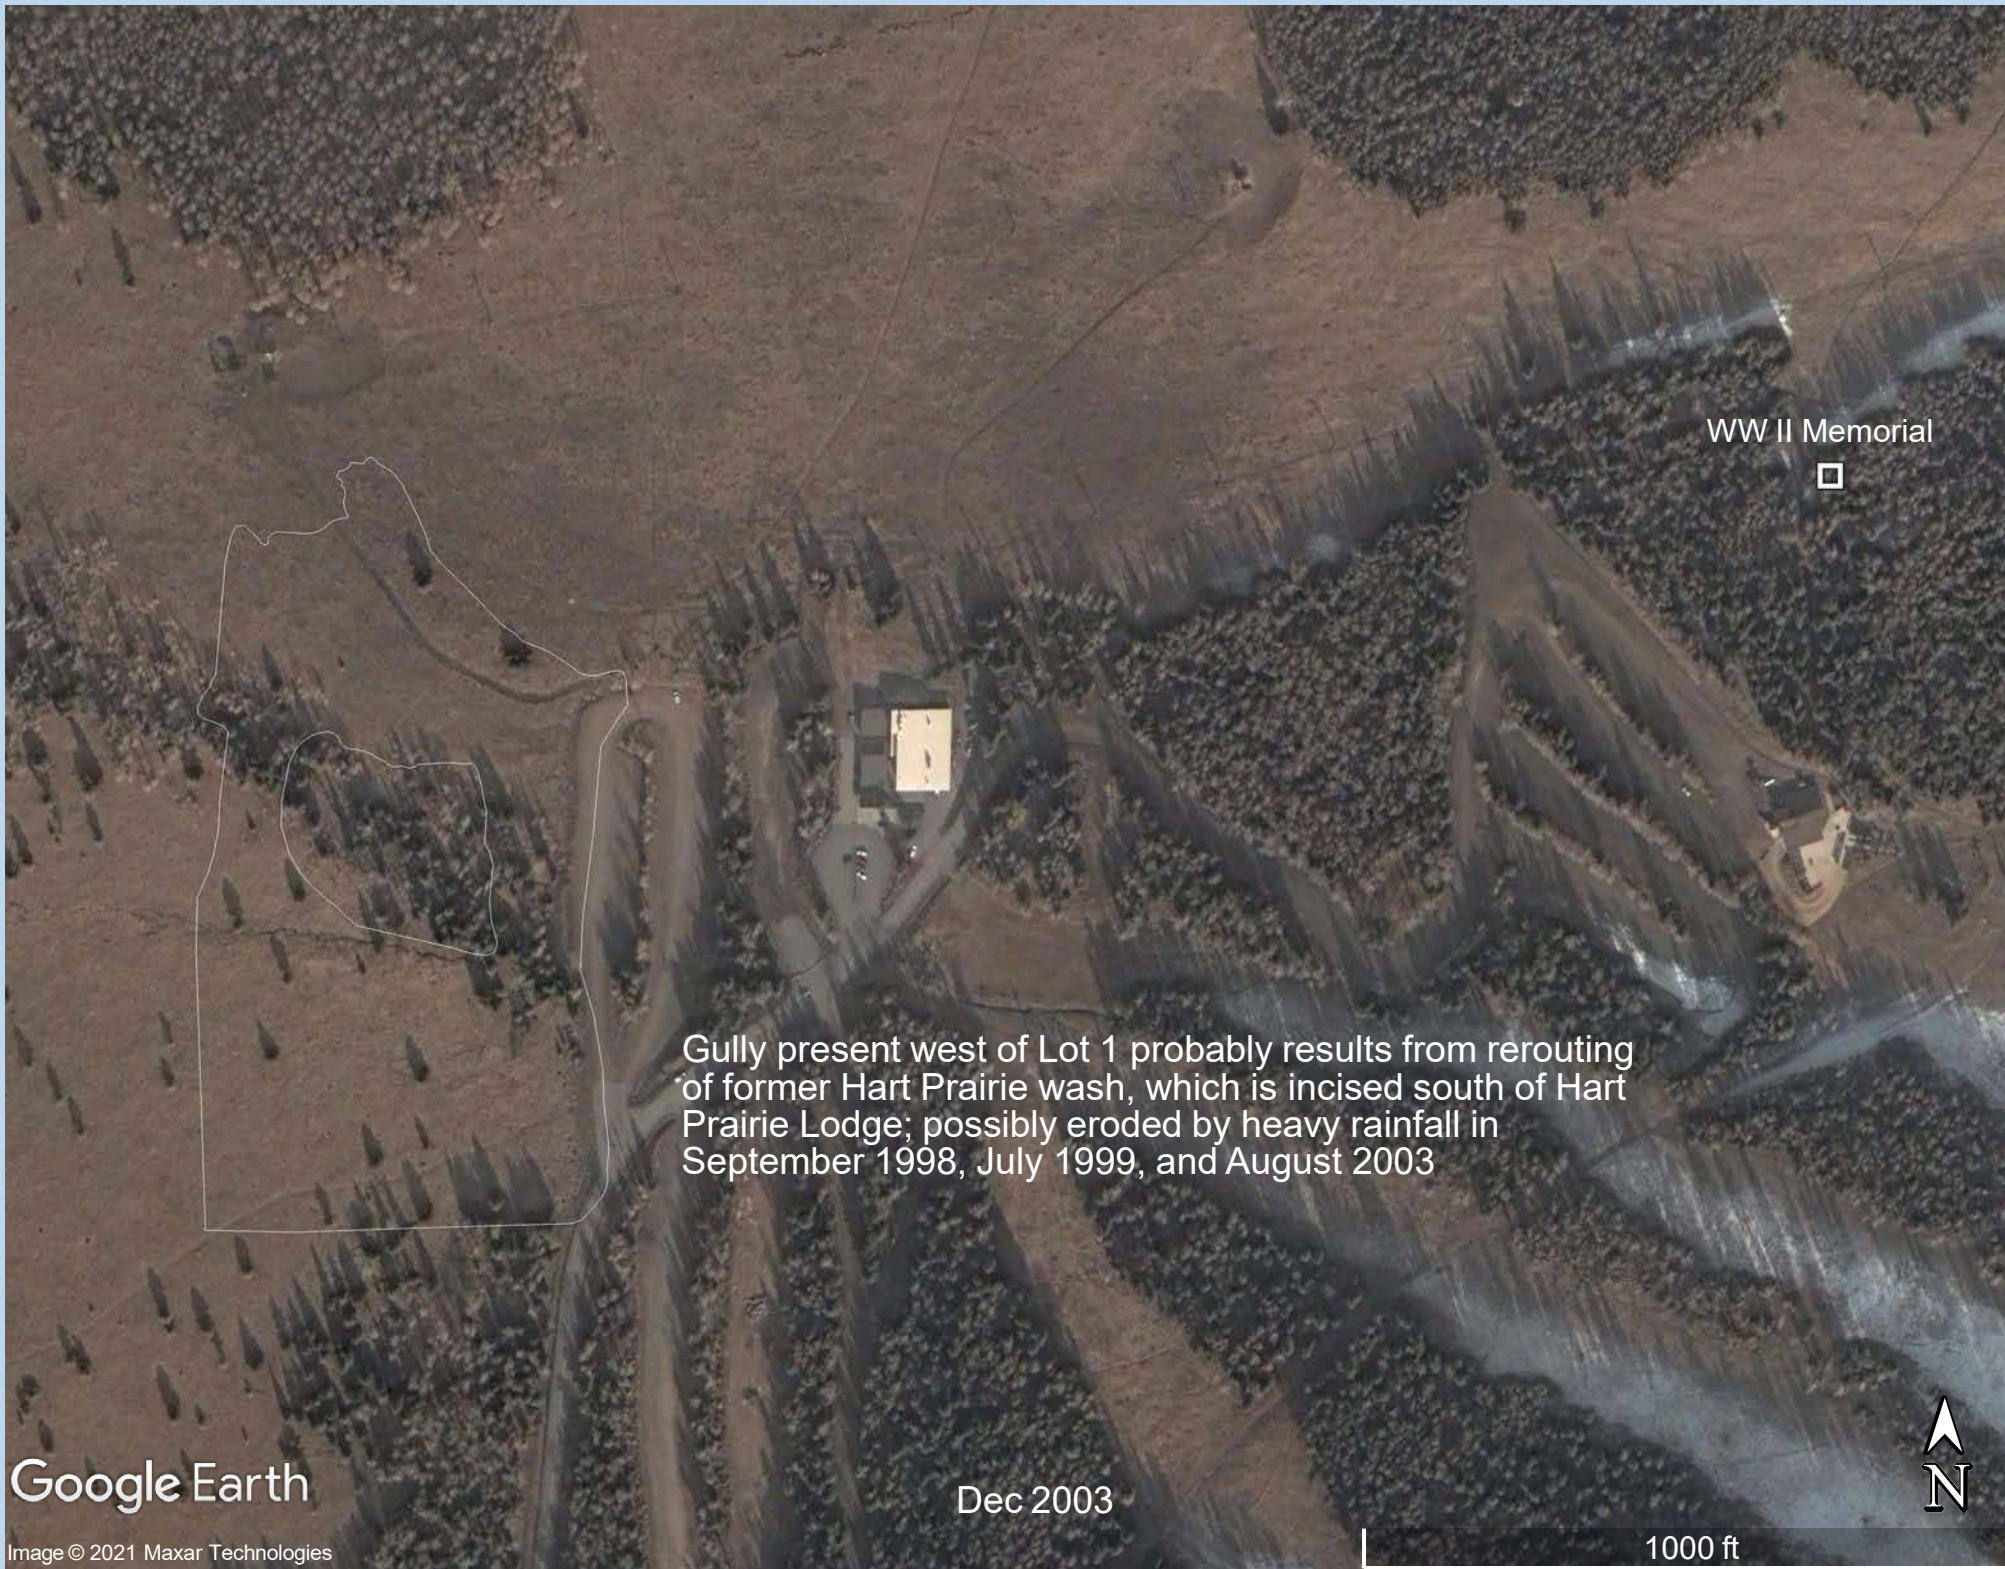
Dec 2003

Gully present west of Lot 1 probably results from rerouting of former Hart Prairie wash, which is incised south of Hart Prairie Lodge; possibly eroded by heavy rainfall in September 1998, July 1999, and August 2003

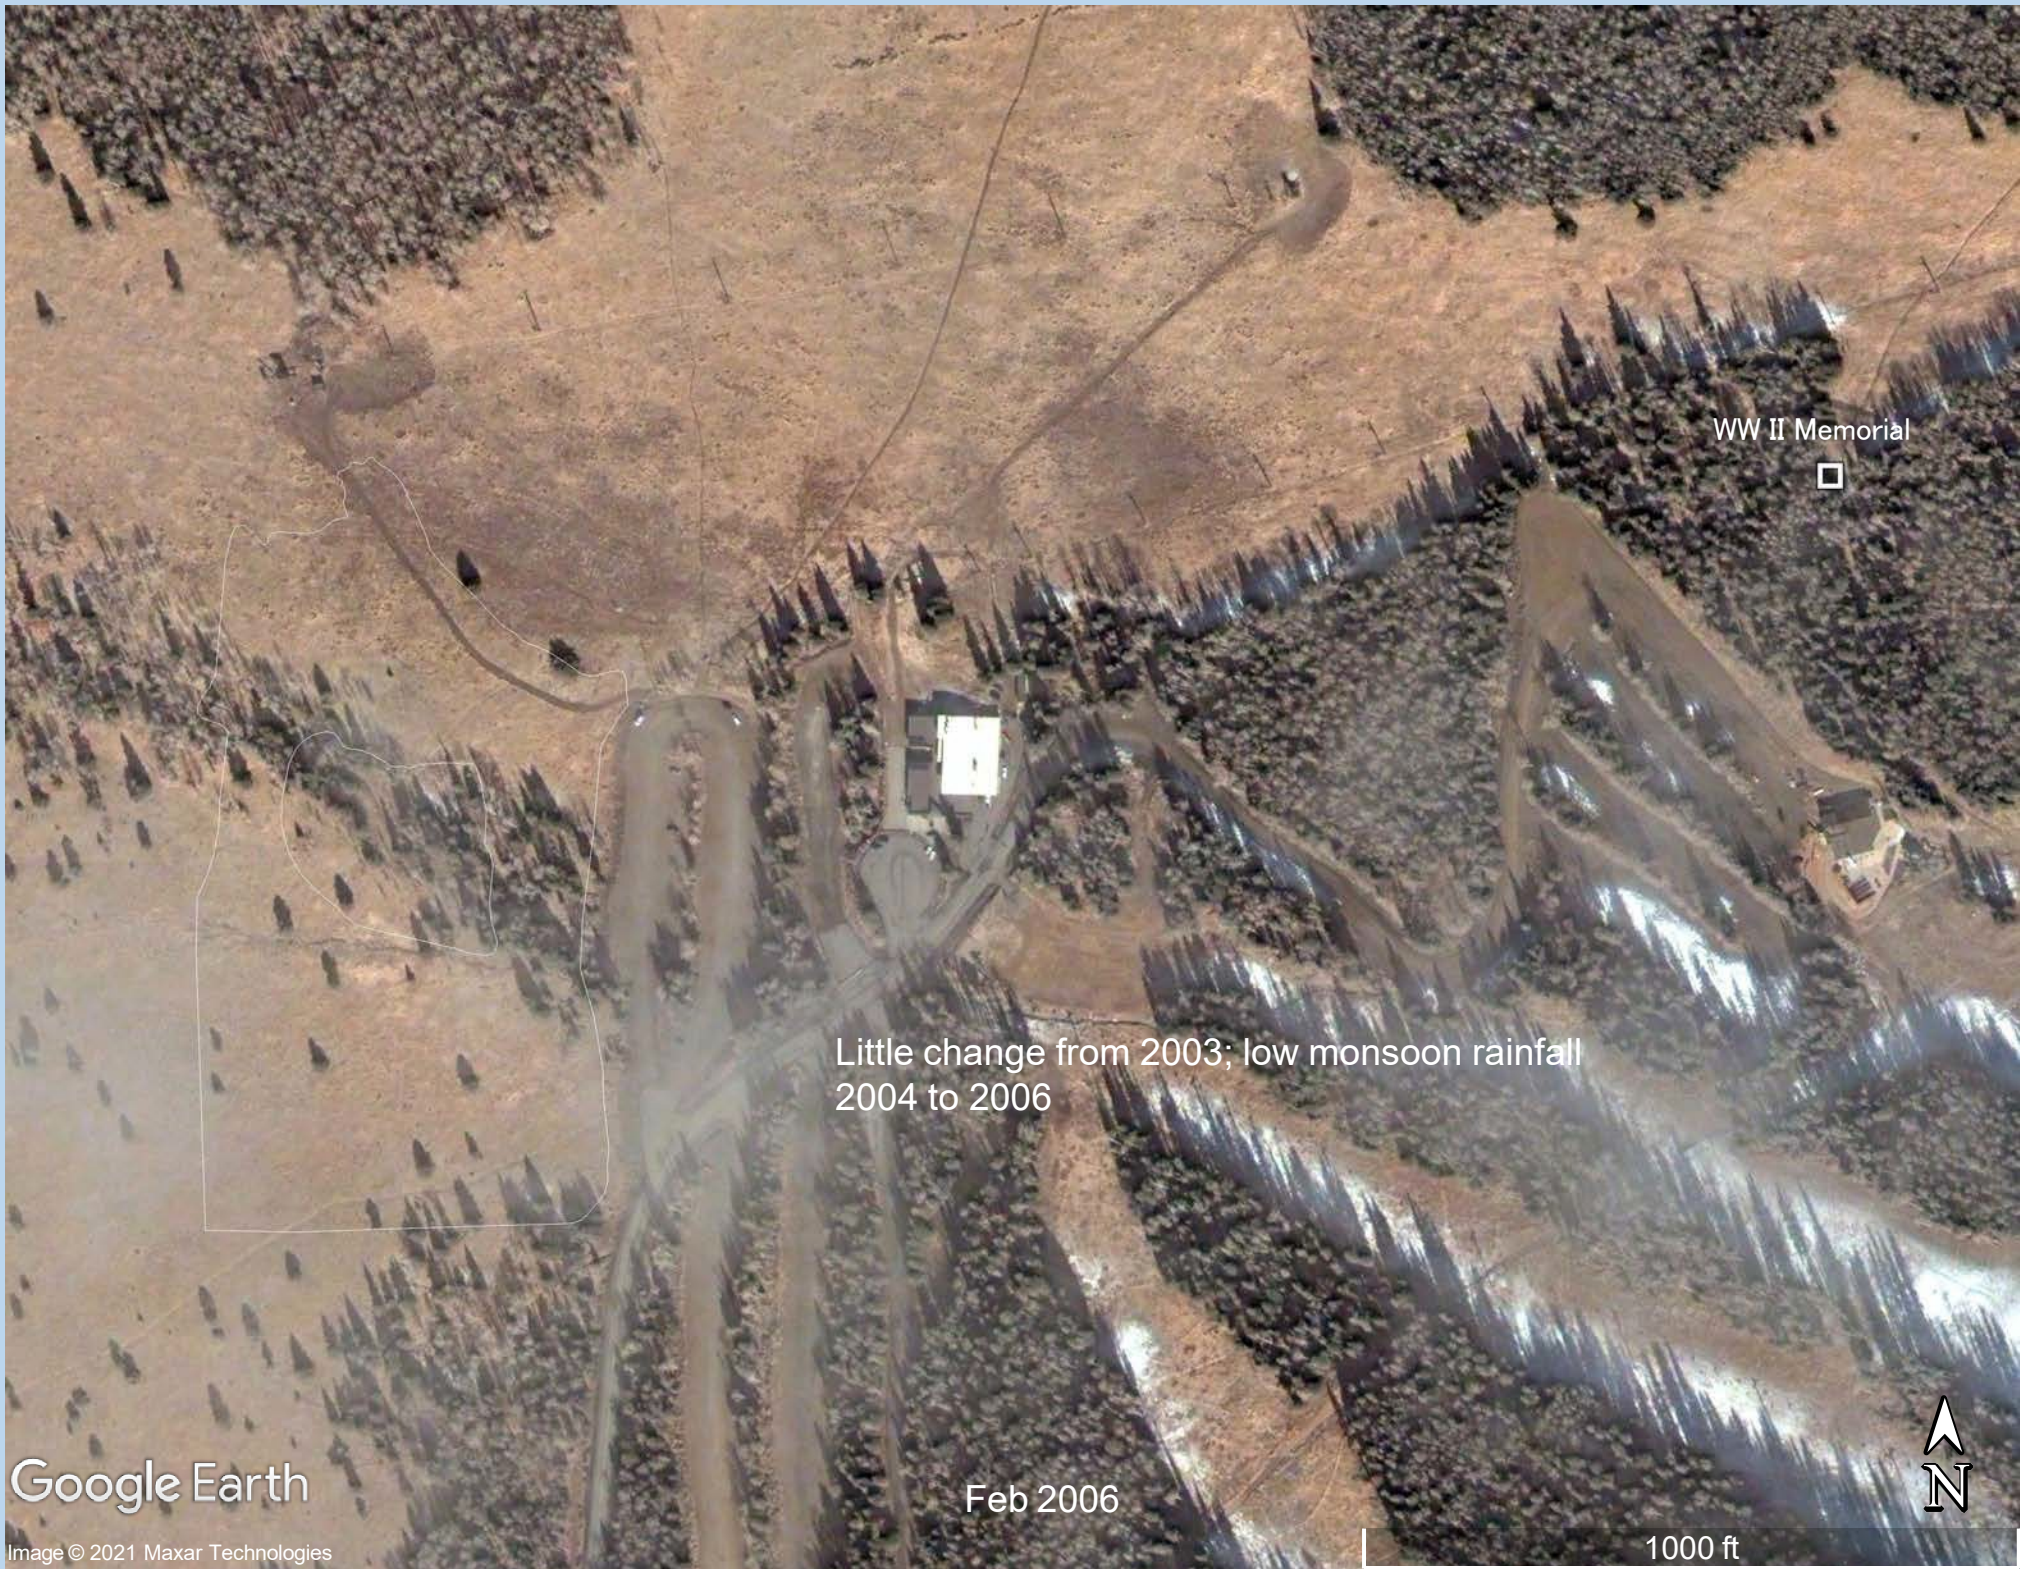
Feb 2006

Little change from 2003; low monsoon rainfall  
2004 to 2006

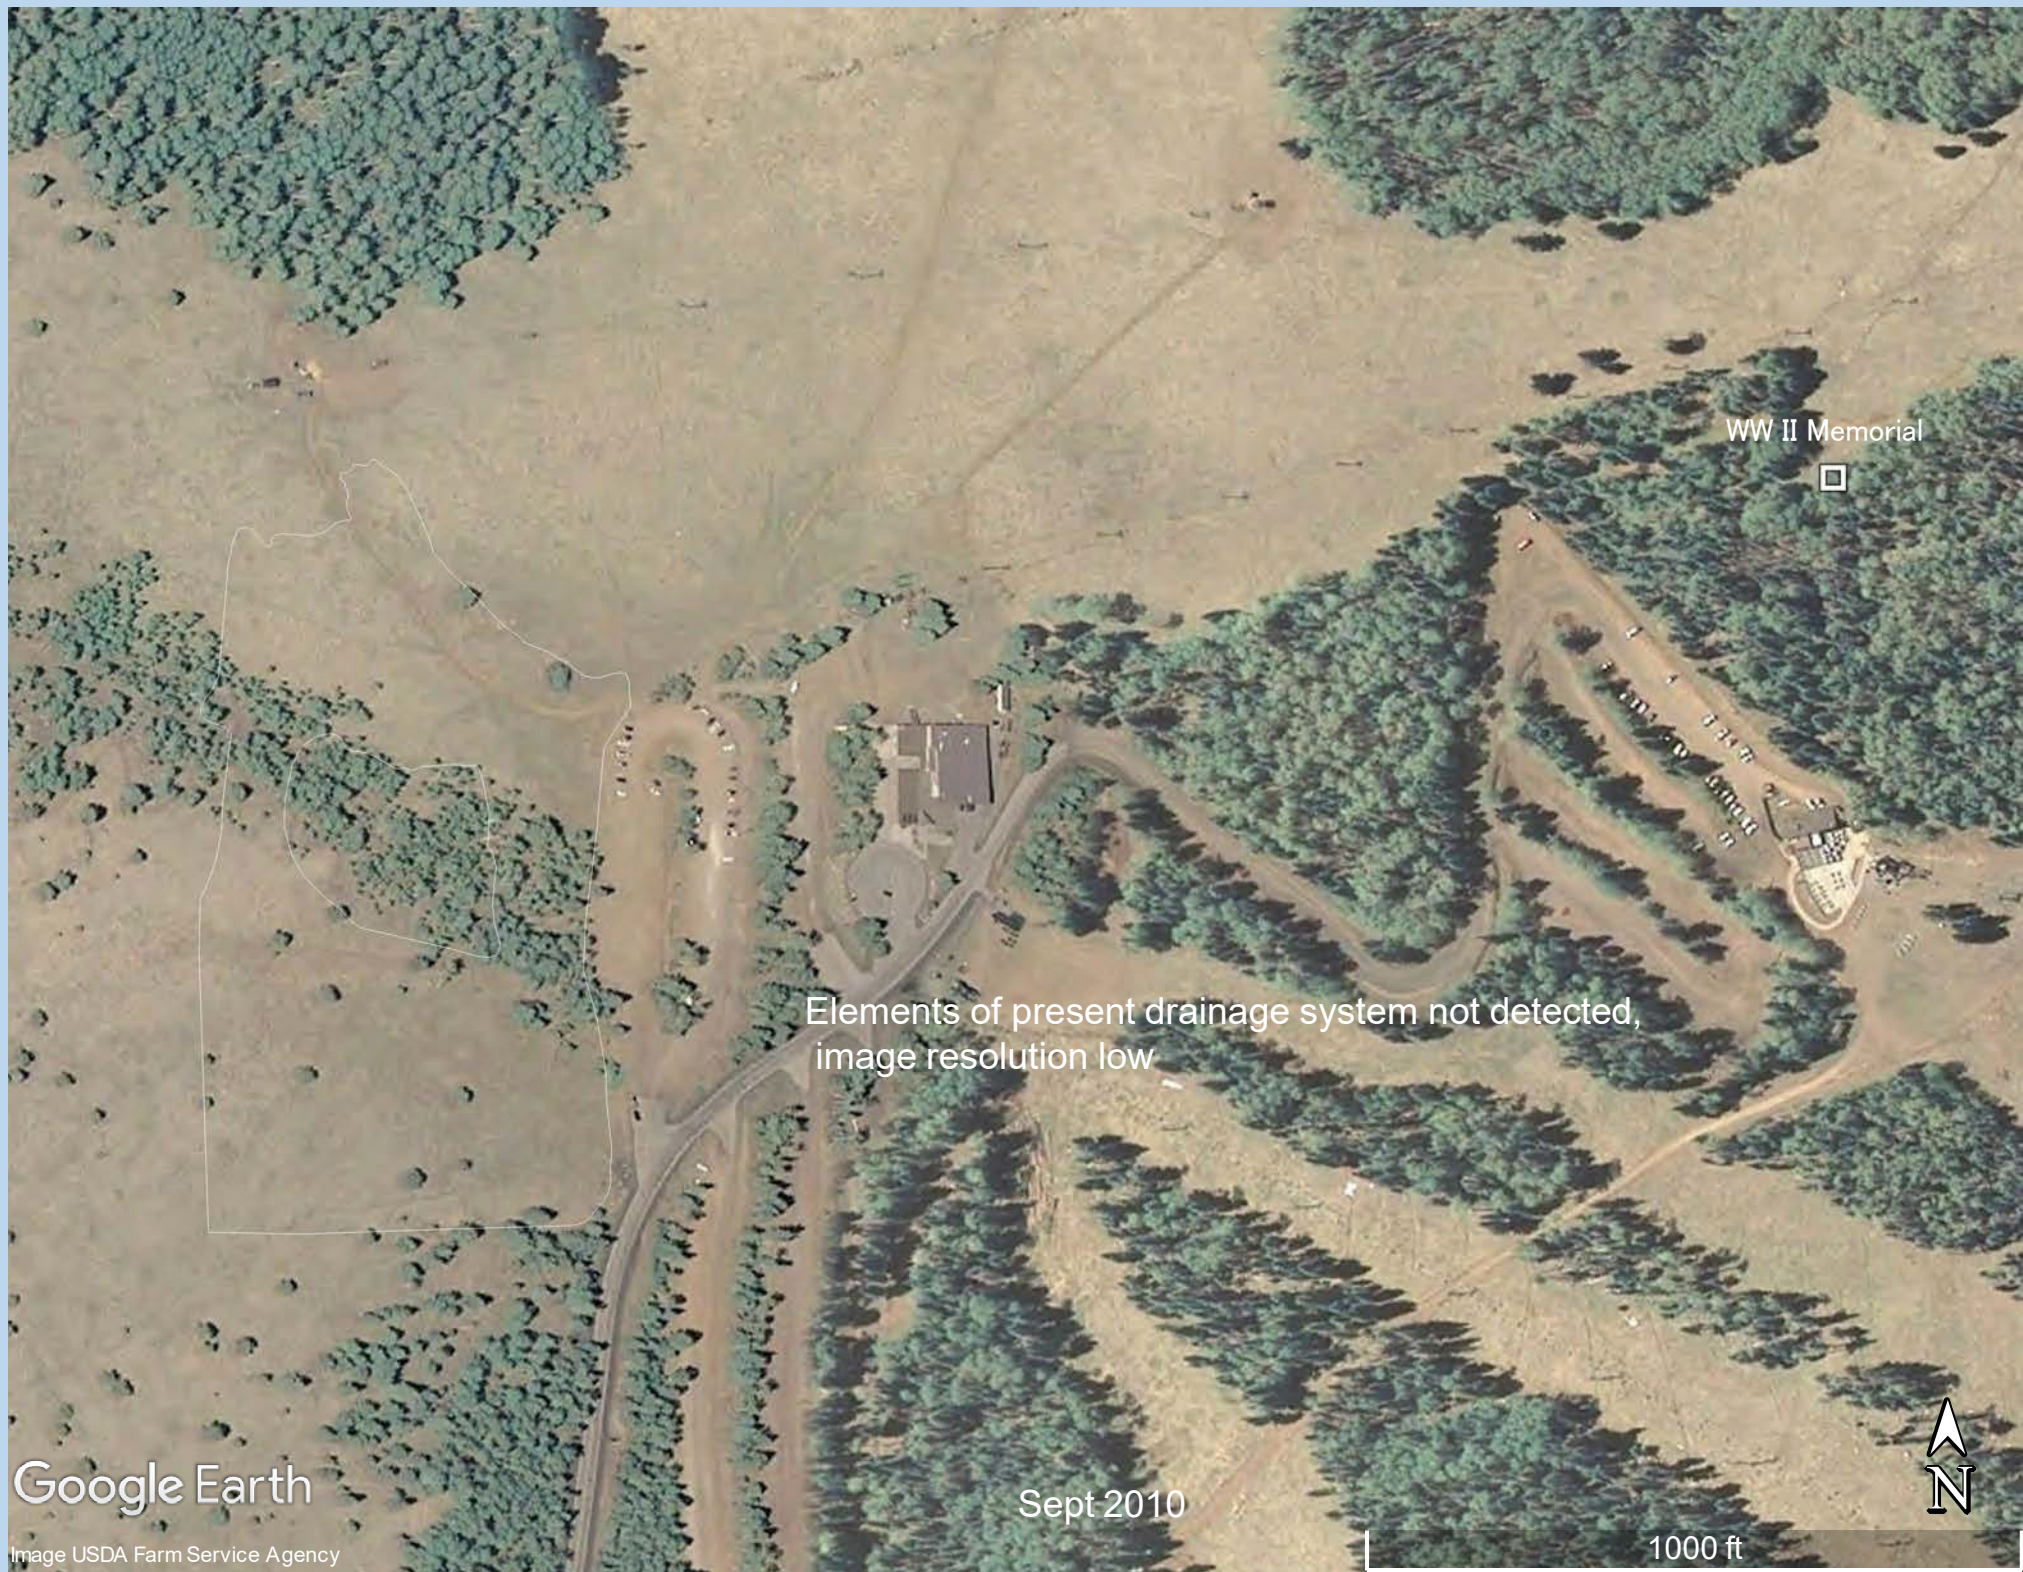
Sept 2010

Elements of present drainage system not detected,  
image resolution low

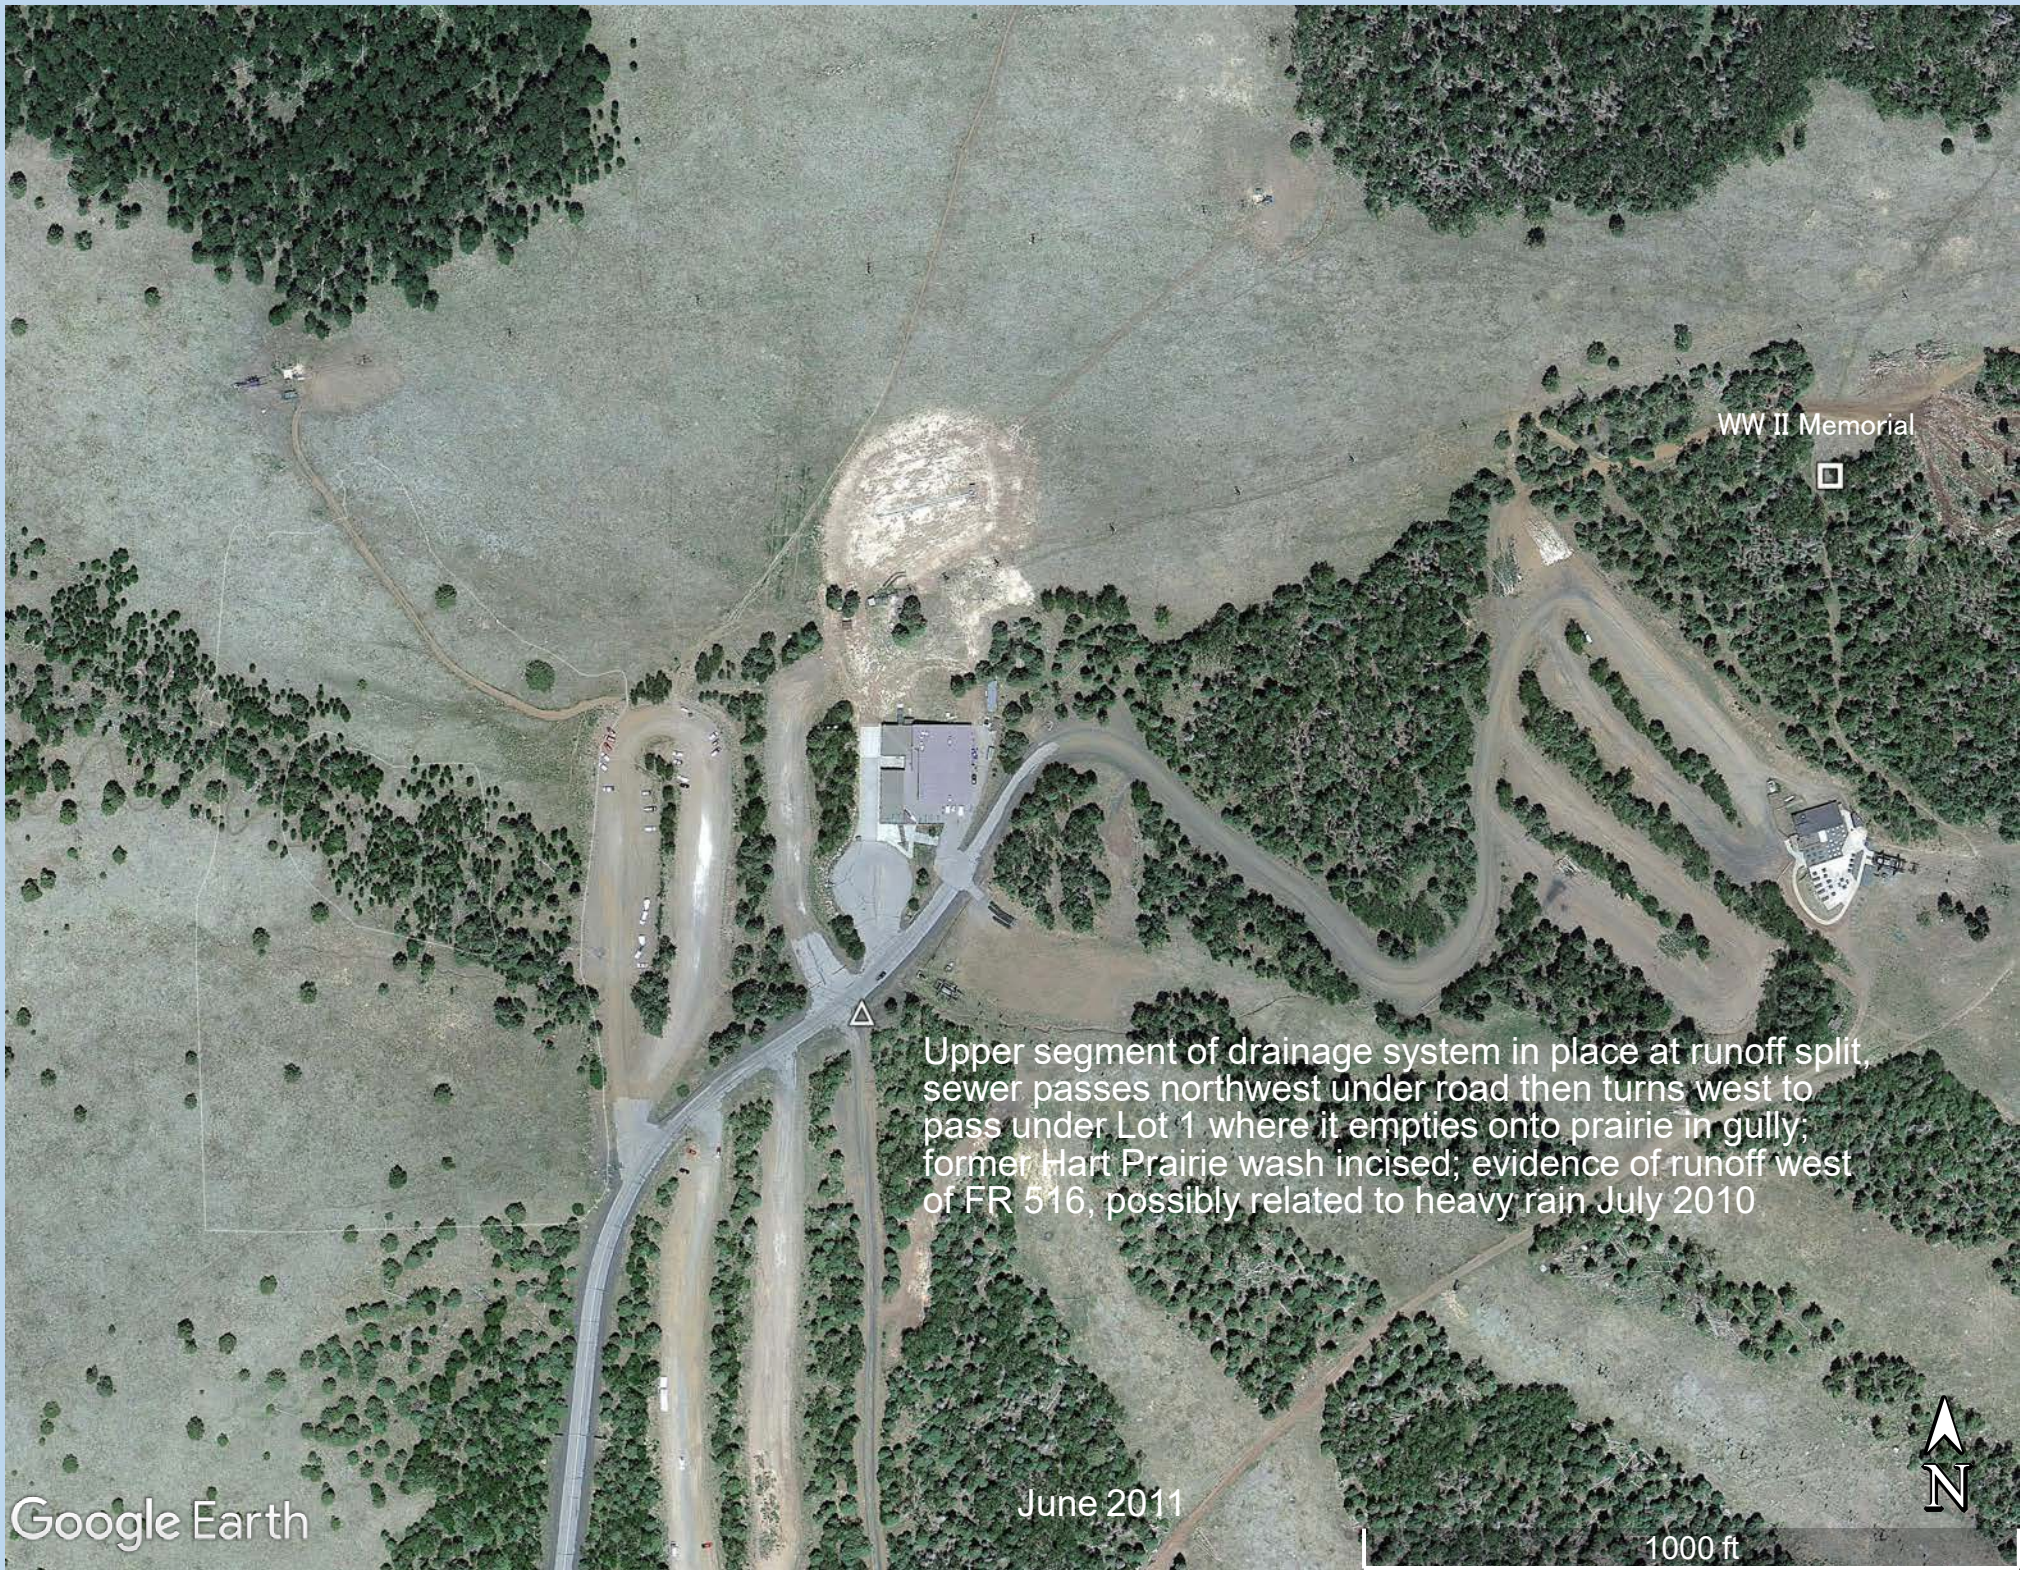
Upper segment of drainage system in place at runoff split, sewer passes northwest under road then turns west to pass under Lot 1 where it empties onto prairie in gully; former Hart Prairie wash incised; evidence of runoff west of FR 516, possibly related to heavy rain July 2010

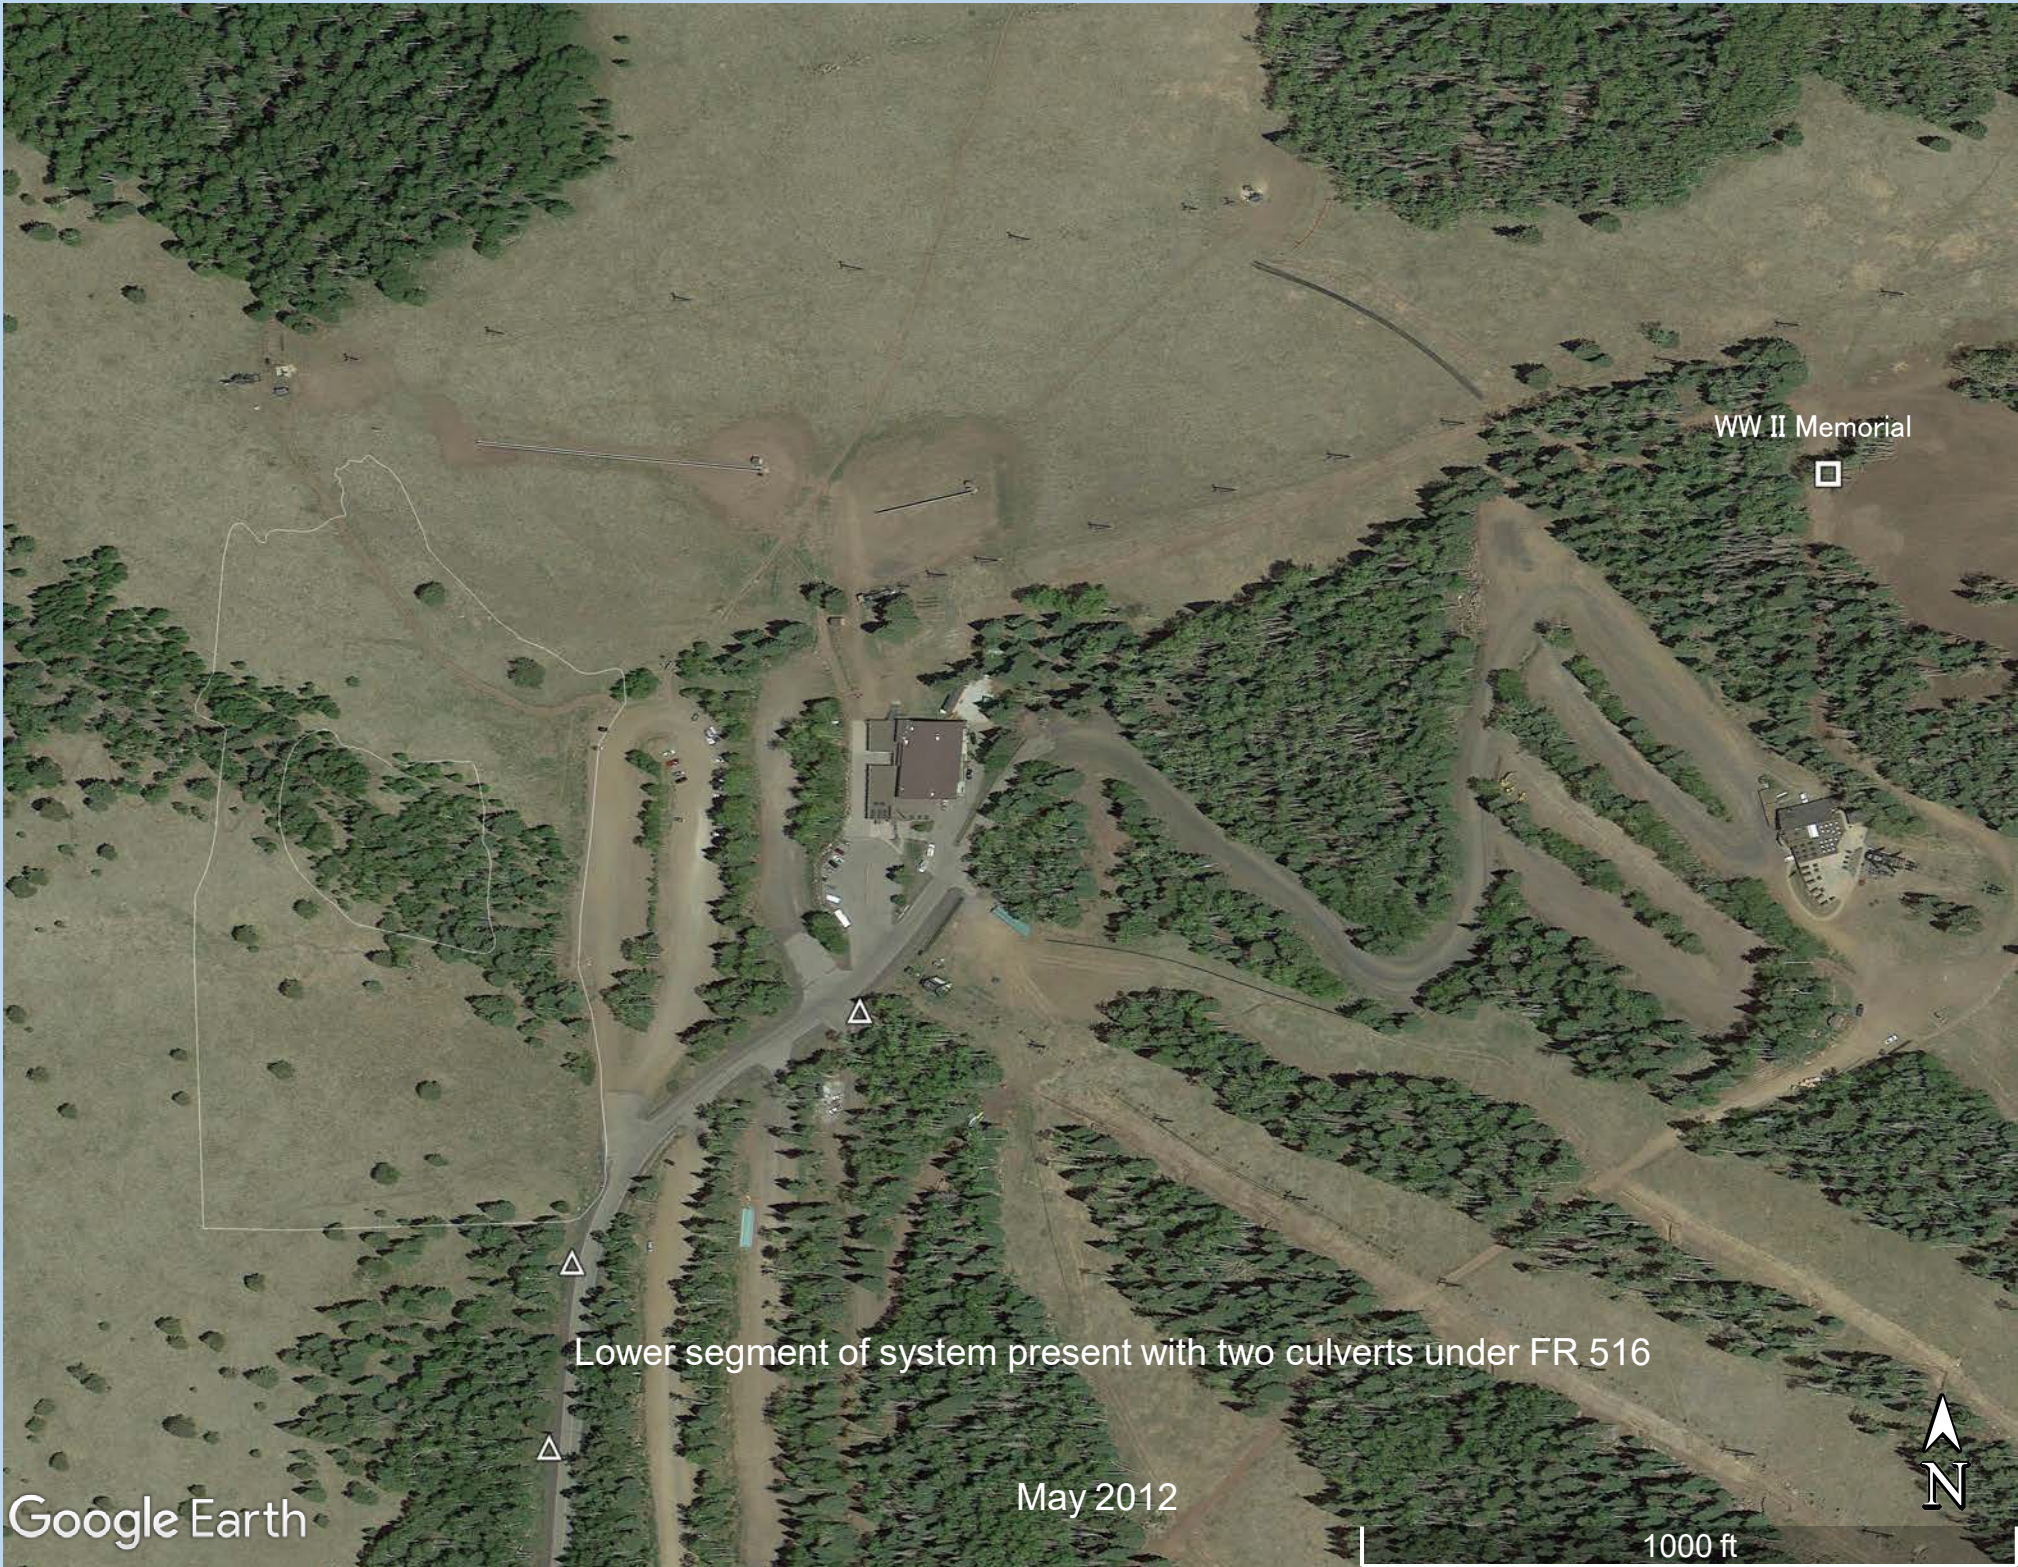
May 2012

Lower segment of system present with two culverts under FR 516

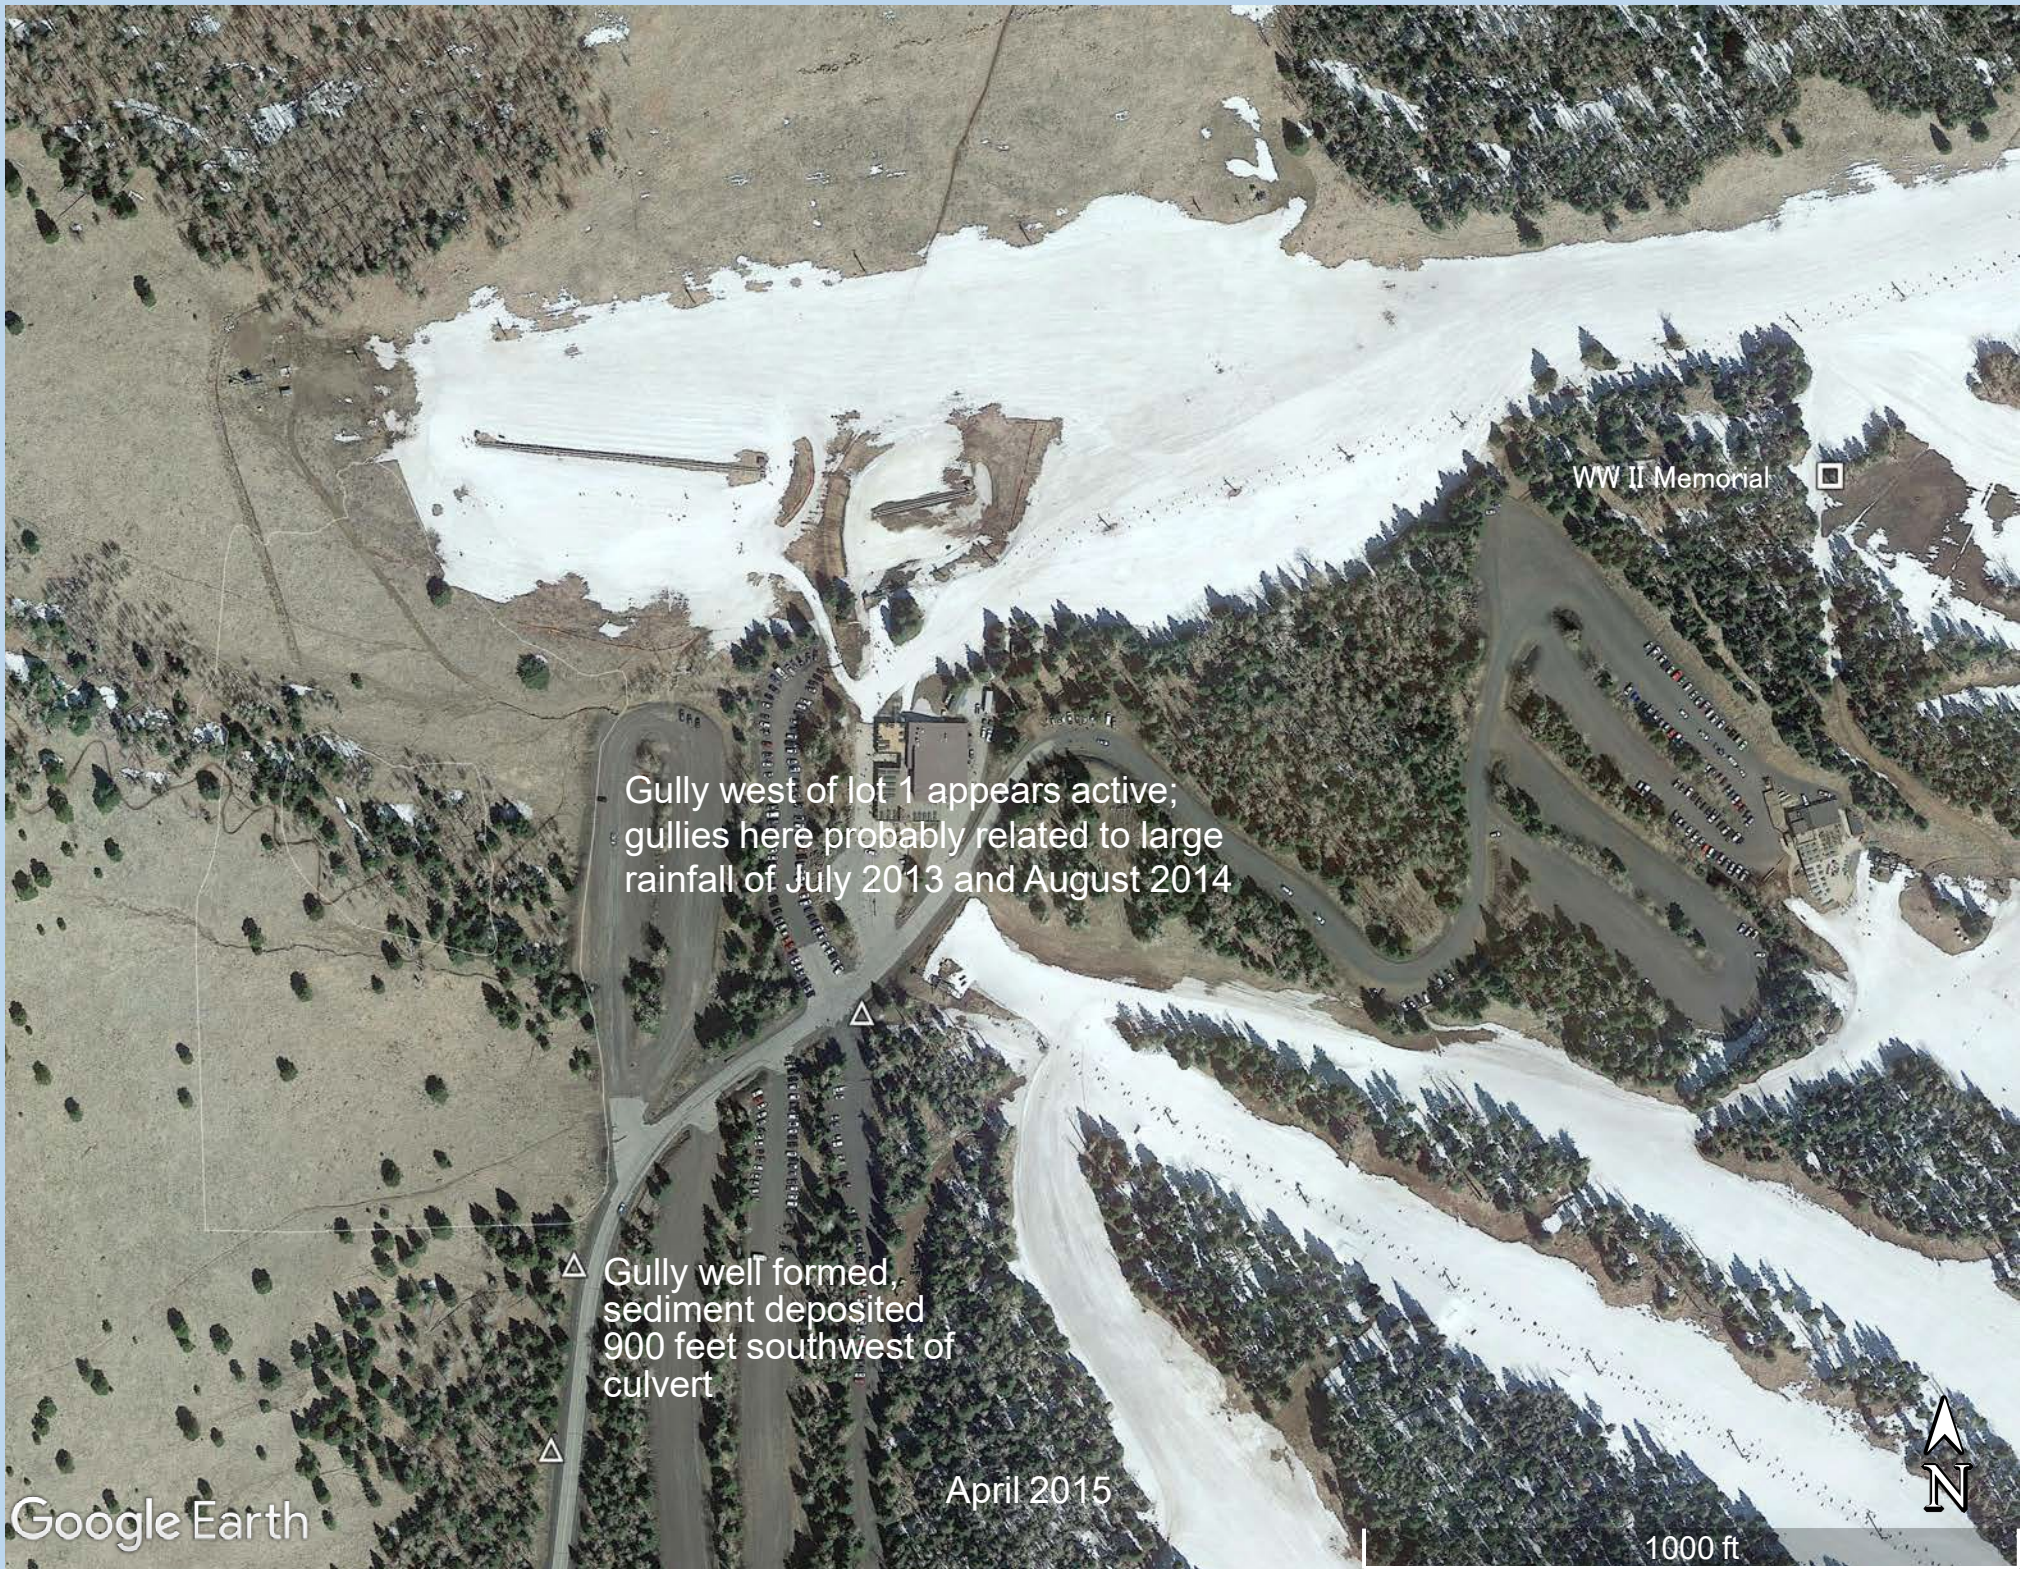
April 2015

Gully west of lot 1 appears active; gullies here probably related to large rainfall of July 2013 and August 2014

△ Gully well formed, sediment deposited 900 feet southwest of culvert

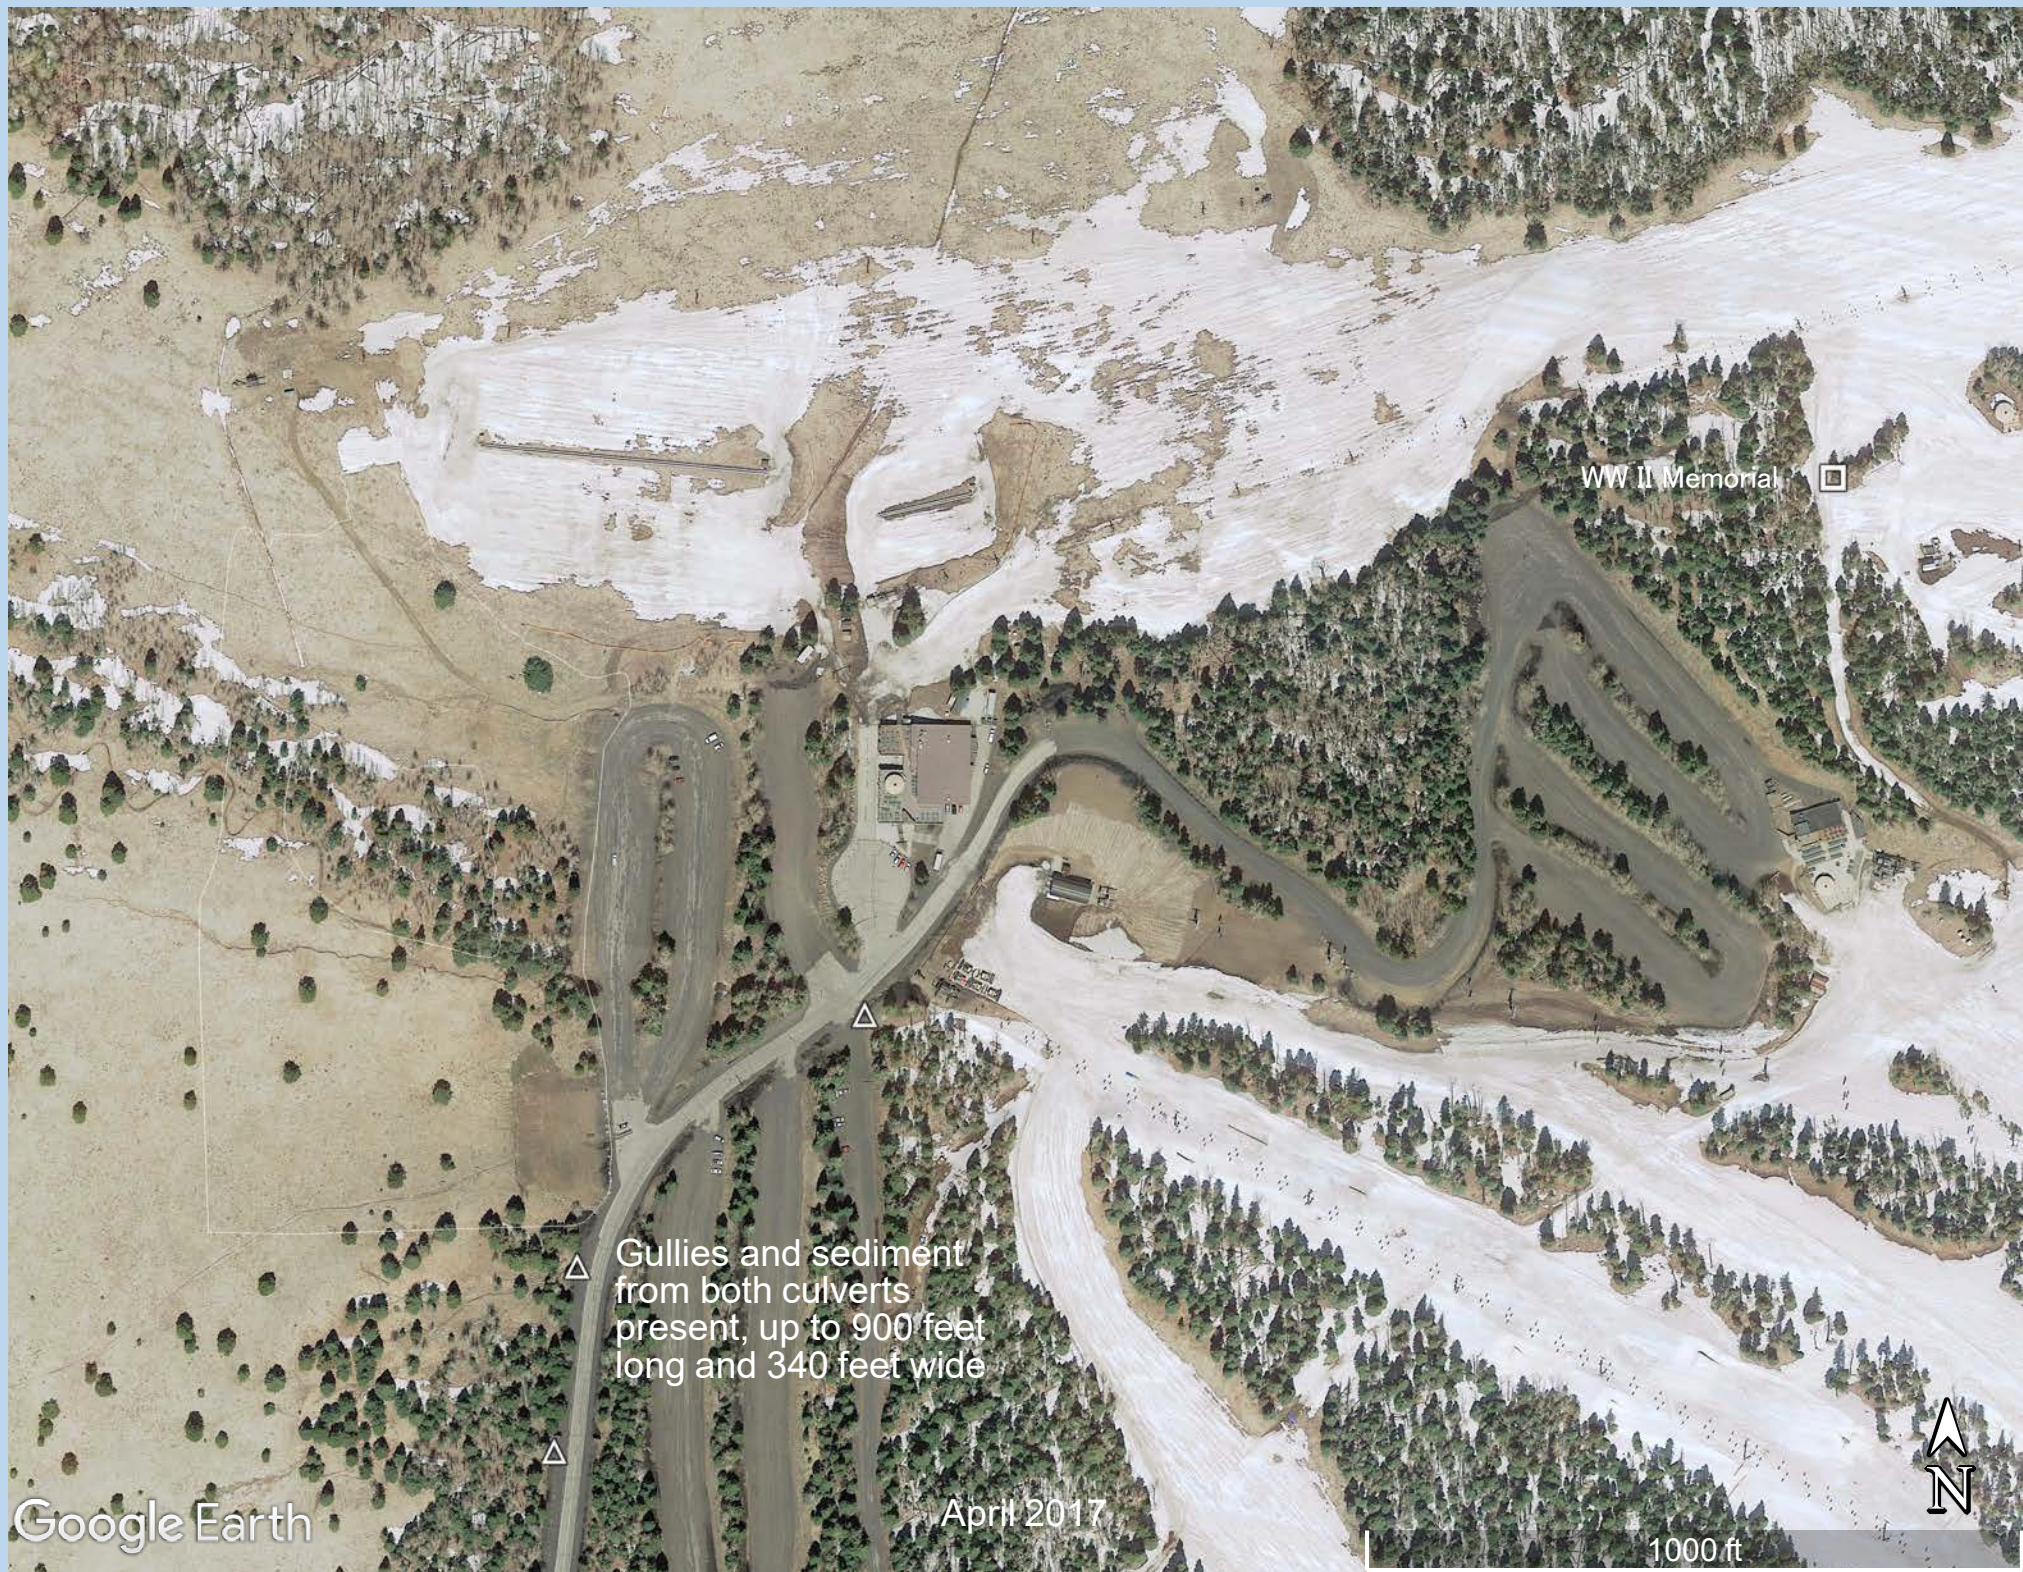
April 2017

△ Gullies and sediment from both culverts present, up to 900 feet long and 340 feet wide
