# **Documented Stormwater Runoff Beyond Arizona Snow Bowl's Permit Area Causes Erosion and Pollution of Hart Prairie's Ecosystem**

**by  
Richard Hereford\*, Tom Brownold, and Gwendolyn  
Waring Flagstaff, Arizona**

*Presented at the  
Sacred Mountain Ecological and Historical Update  
Flagstaff, Arizona  
August 19, 2022*

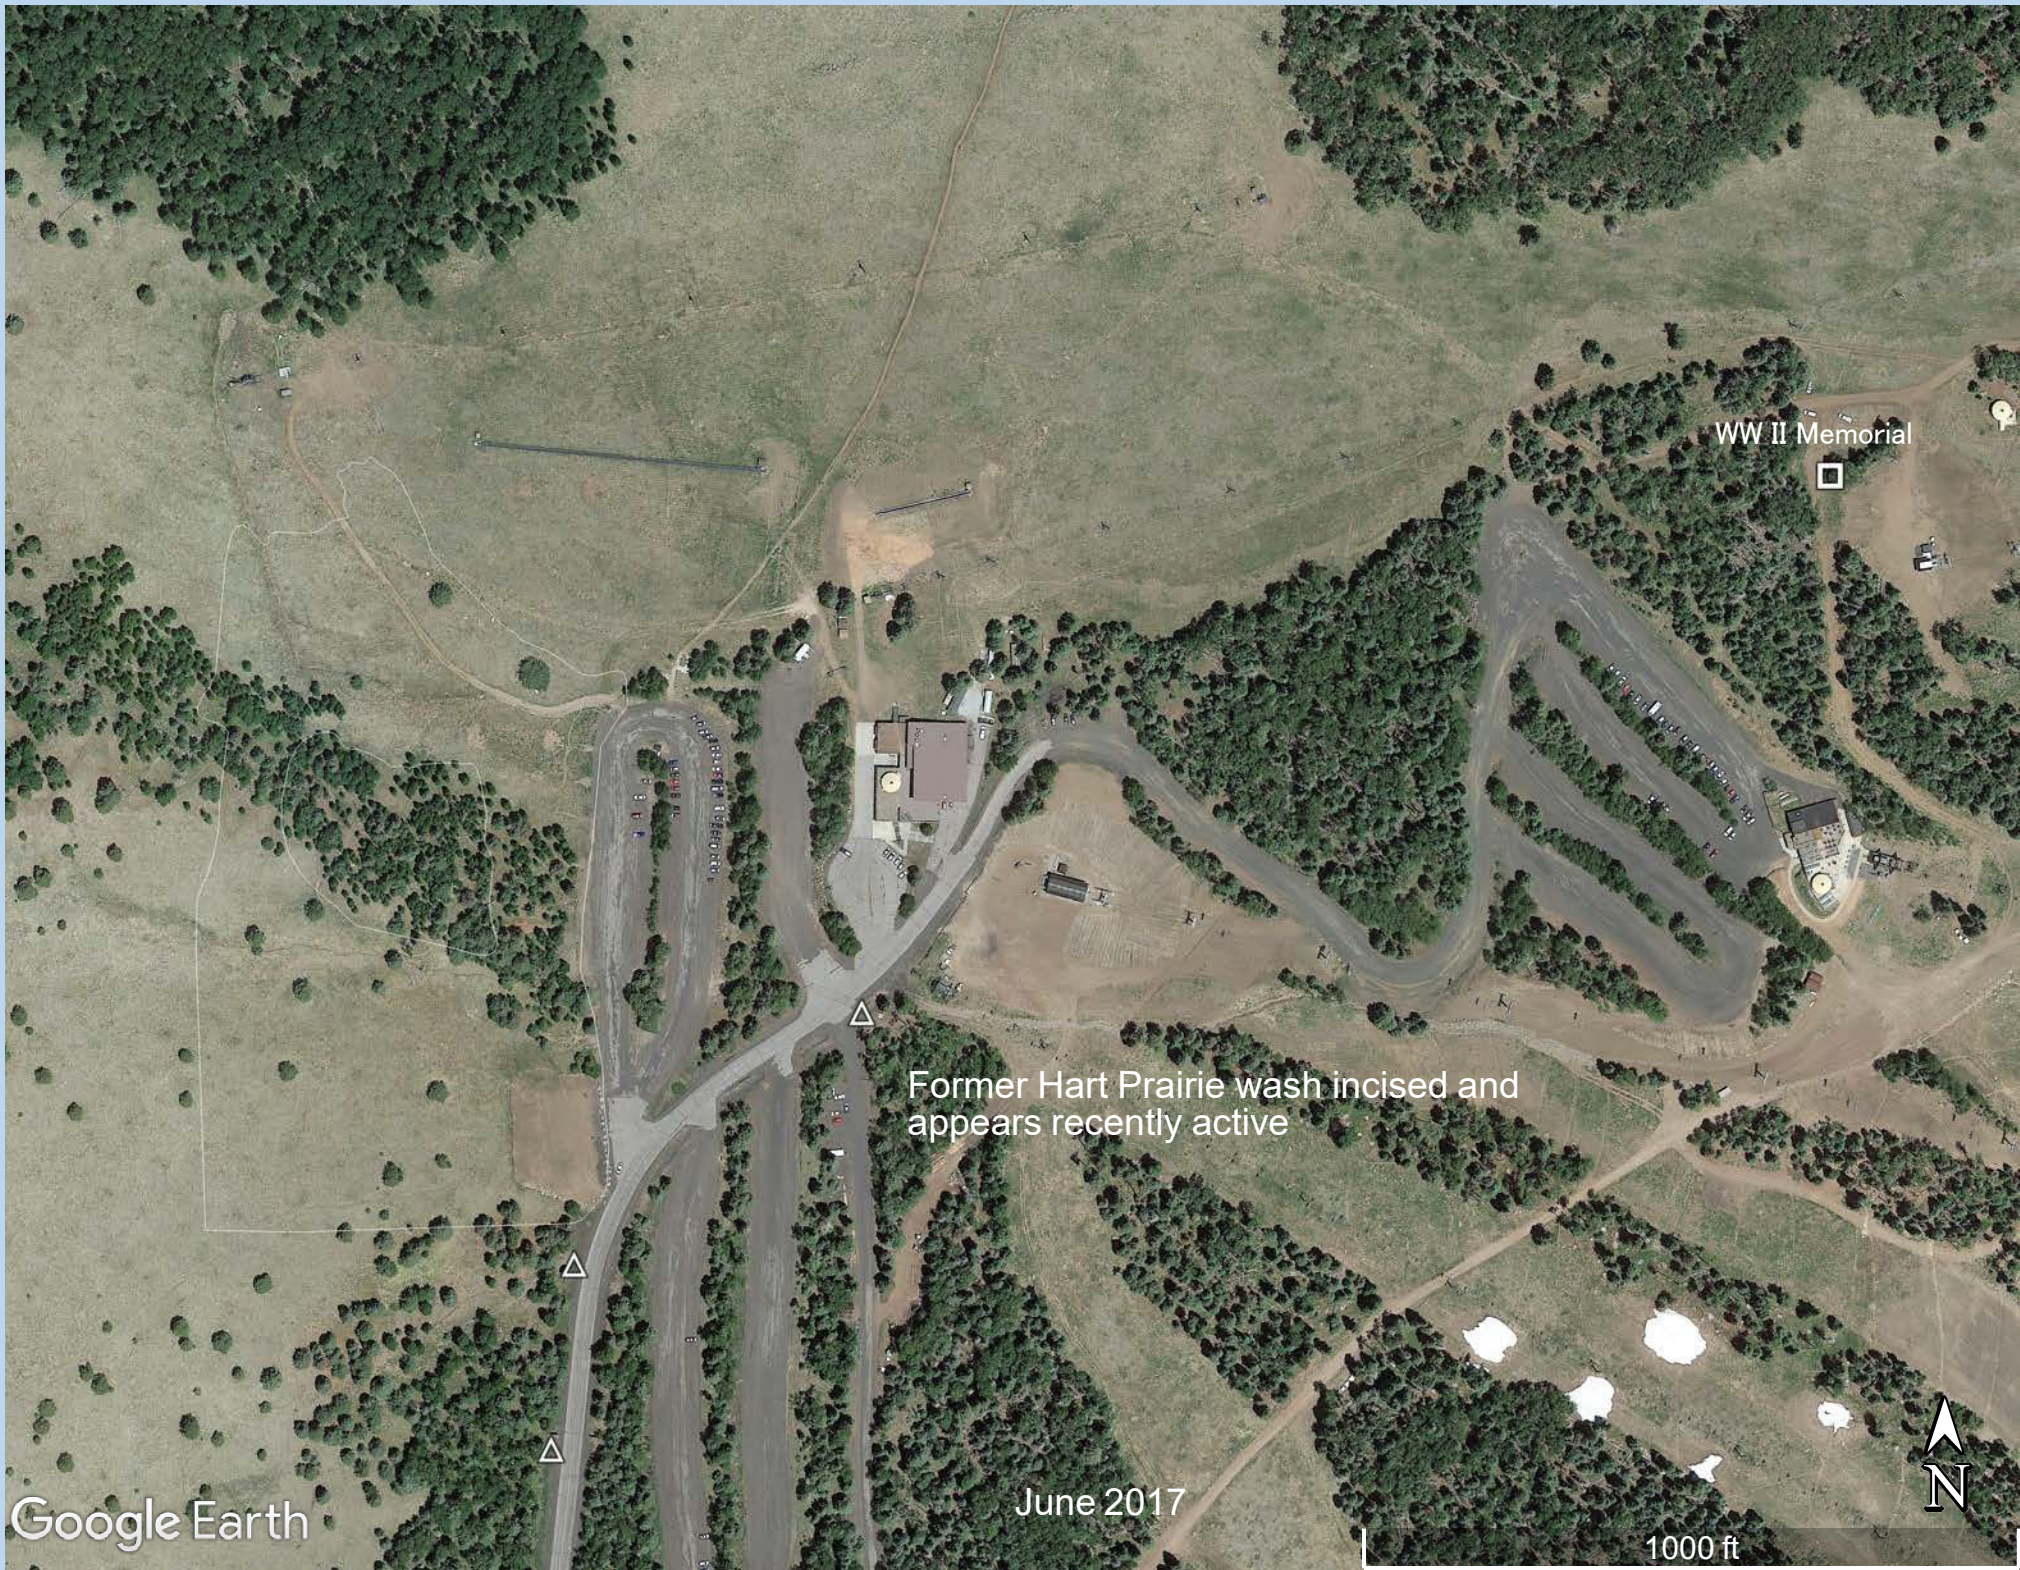
June 2017

Former Hart Prairie wash incised and appears recently active

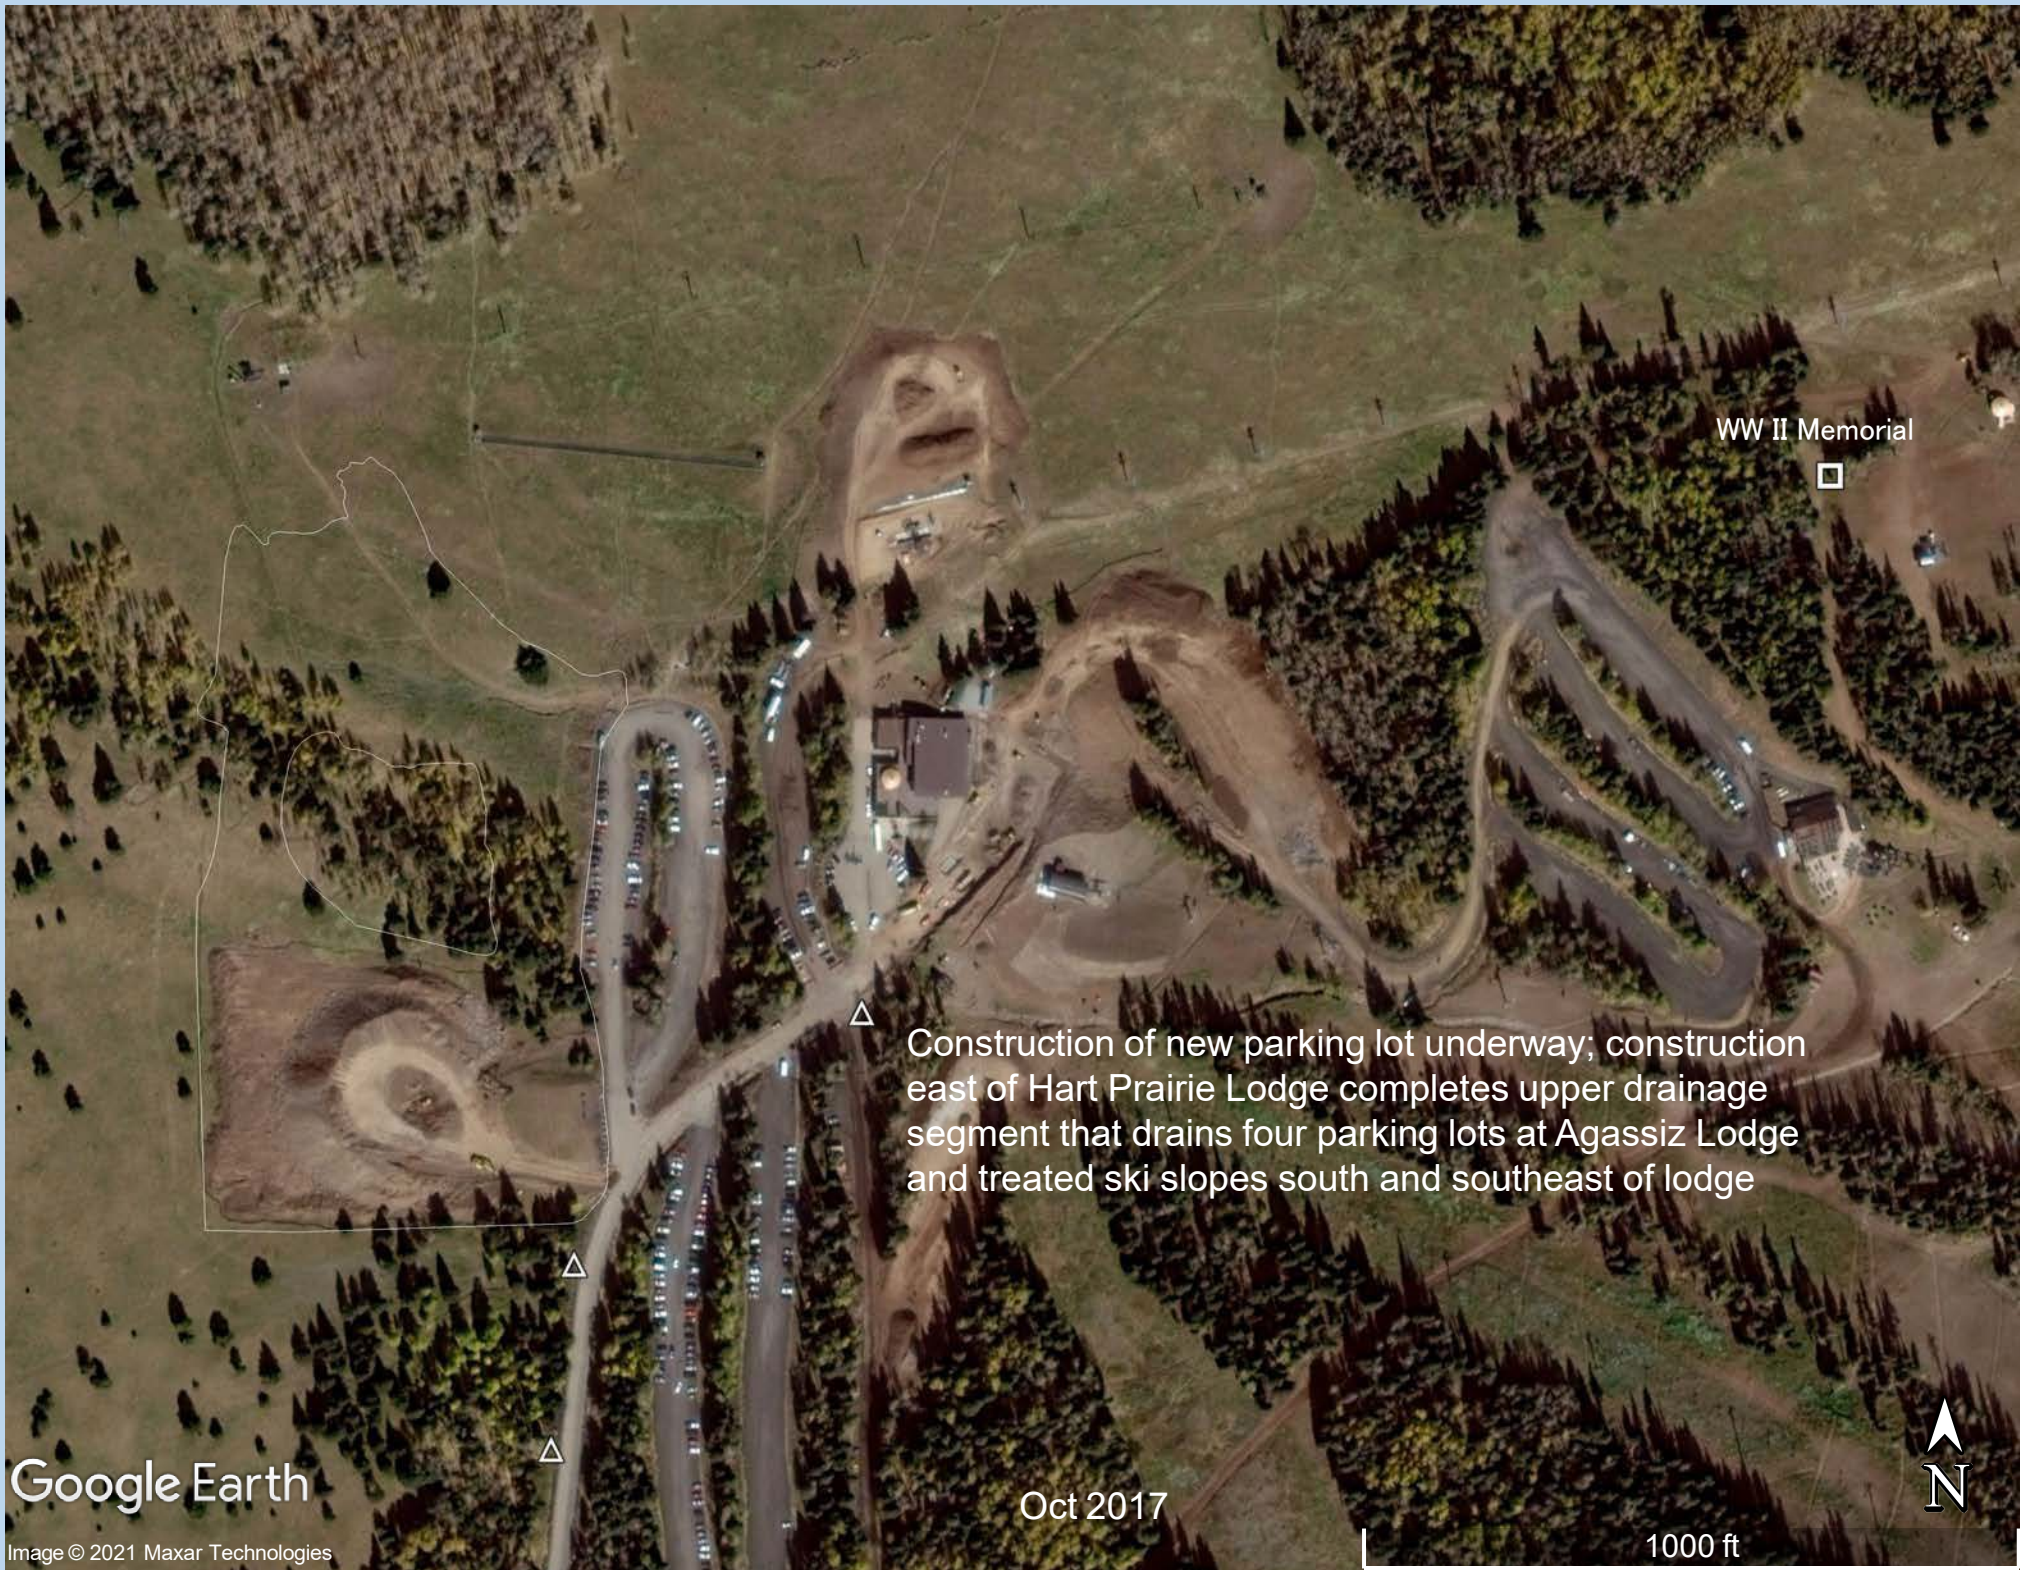
Oct 2017

Construction of new parking lot underway; construction east of Hart Prairie Lodge completes upper drainage segment that drains four parking lots at Agassiz Lodge and treated ski slopes south and southeast of lodge
