# The Effects of Surface Runoff on Hart Prairie from Arizona Snow Bowl Facilities, Coconino National Forest

*Richard Hereford, Research Geologist Emeritus*

Spring 2023

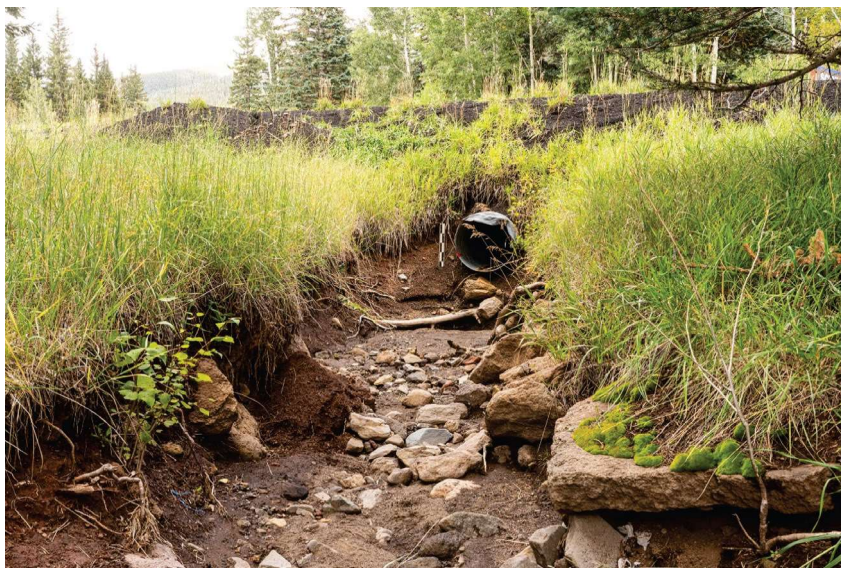
**FIGURE 4** Upstream views of gully related to runoff at the sampling and measurement locality (fig. 2). (A) Gully at culvert incised since 2011 (Table 1). (B) Gully 220 ft downstream from culvert; knickpoint (abrupt channel steepening) in foreground. These migrate upstream and downstream widening and deepening the channel. Scale 50 centimeters (1.6 ft).

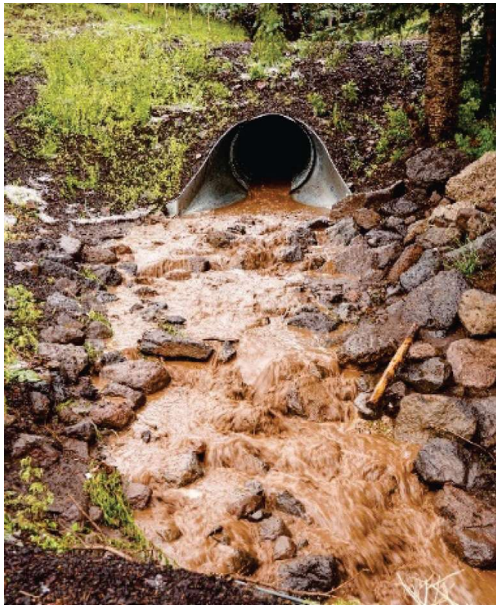
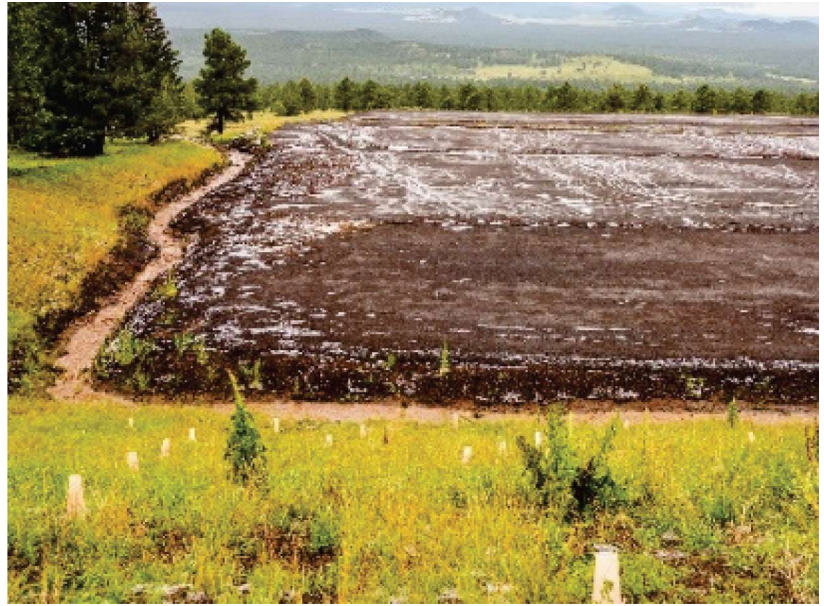
**FIGURE 5** Stormwater runoff, afternoon Aug. 14, 2022. (A) Upper segment flowing under Lot 1. (B) Flow from (A) passes around the south side of Lot 5 to exit on Hart Prairie (upper left). (C) Lower segment stormwater flowing onto Hart Prairie at sample and measurement culvert; pavement of FR 516 at top.

The observed and measured runoff events (Table 2 and fig. 5) do not support the hypothesis of no surface runoff. Furthermore, the satellite imagery documents runoff from multiple sites related to the stormwater drainage system. These observed events, moreover, are not abnormalities as shown by the previously described soil mapping. Significantly, deposits of active and inactive alluvial channels, bars, and low terraces in several drainages of southern San Francisco Mountain were mapped by Youberg and Ben-Horin (2021); these features are evidence of recurring and recent runoff. Their results demonstrate that substantial runoff from drainages on the mountain has occurred throughout the Holocene (the past 11,000 years) or at least the past several thousand years. The key runoff indicators are substantial rainfall, snowmelt, or rain-on-snow events, although little is known about the latter two. However, snowmelt runoff in April 2023 produced enough runoff to reach the Rio de Flag in Fort Valley 8.2 miles south of the prairie.

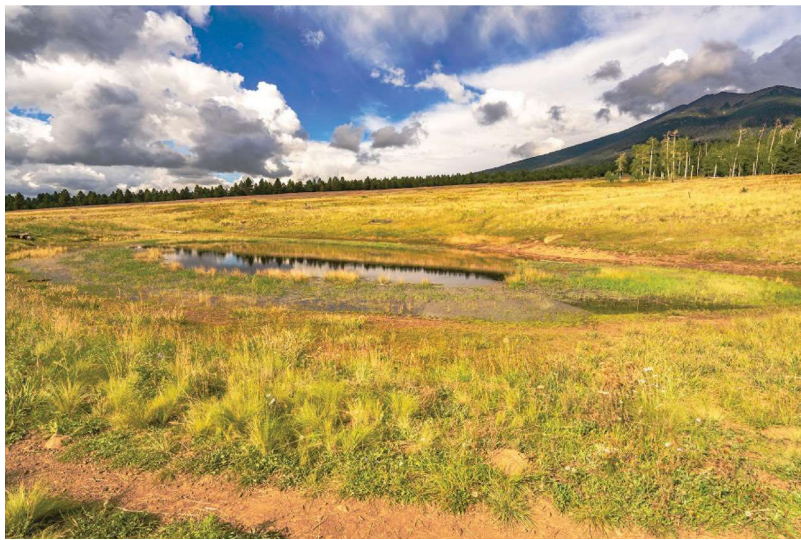
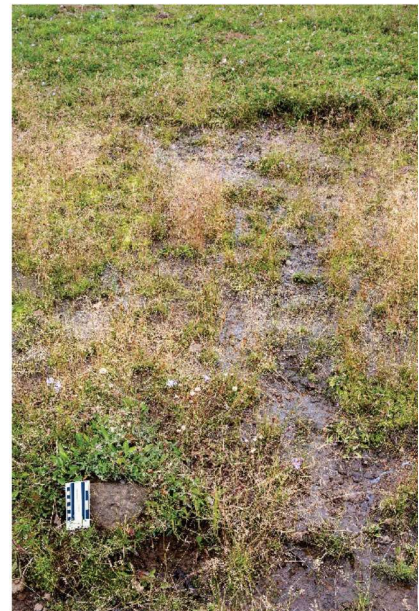
**FIGURE 6** Alfa Fia tank and seeps southwest of Snow Bowl. (A) Mapped path of runoff on Hart Prairie, July 18, 2021. (B) Alfa Fia tank with Snow Bowl basin upper right skyline, and (C) one of two seeps feeding tank on distant shore of earthen tank, September 9, 2022 (scale 10 cm).

earlier runoff on the southwest side of the fan was not found. The trajectory of this runoff was directed toward Alfa Fia tank, a perennial constructed earthen stock tank fed by two seeps. Larger flows, such as the 21.7 cfs of summer 2021 and the earlier 32.7 cfs would likely reach the tank (fig. 6).
