# **Documented Stormwater Runoff Beyond Arizona Snow Bowl's Permit Area Causes Erosion and Pollution of Hart Prairie's Ecosystem**

**by  
Richard Hereford\*, Tom Brownold, and Gwendolyn  
Waring Flagstaff, Arizona**

*Presented at the  
Sacred Mountain Ecological and Historical Update  
Flagstaff, Arizona  
August 19, 2022*

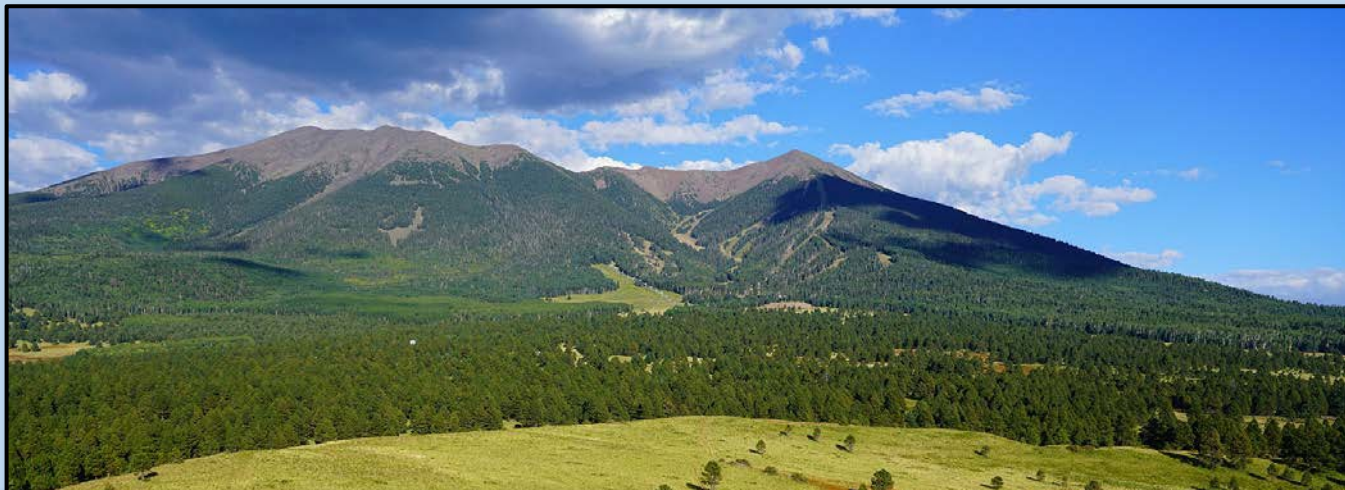
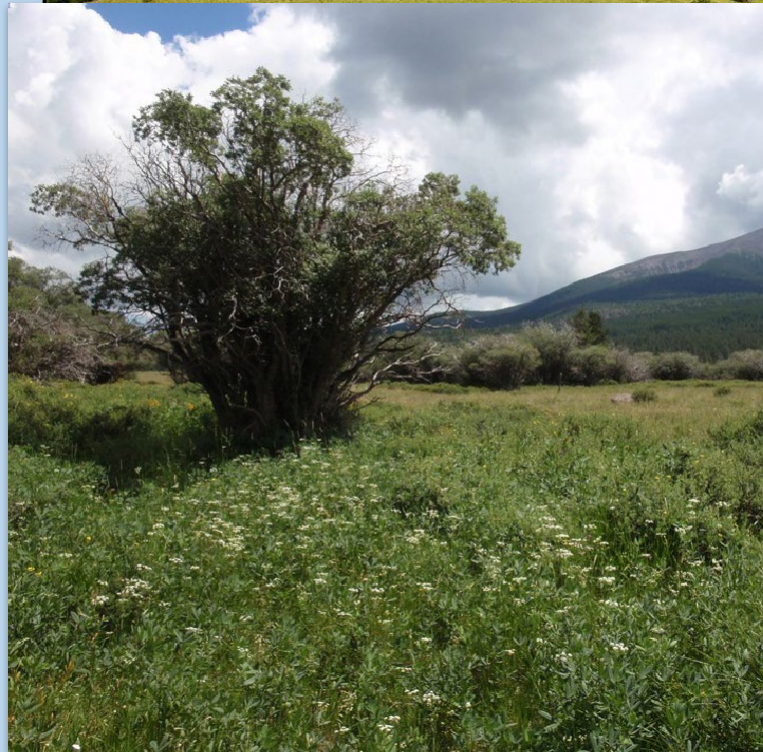
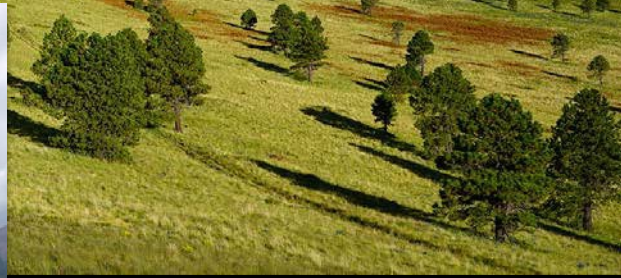
**Above**—West side of San Francisco Mountain and Hart Prairie. Snow bowl basin is in center of the photograph. Ski runs and lifts above the prairie comprise Arizona Snow Bowl. **Below**—Typical display of vegetation on the prairie; Bebb's willow (*Salix Bebbiana*) on the middle left and Arizona fescue (*Festuca arizonica*), a perennial bunch grass lies across mid-ground (Photograph courtesy of Max Licher).

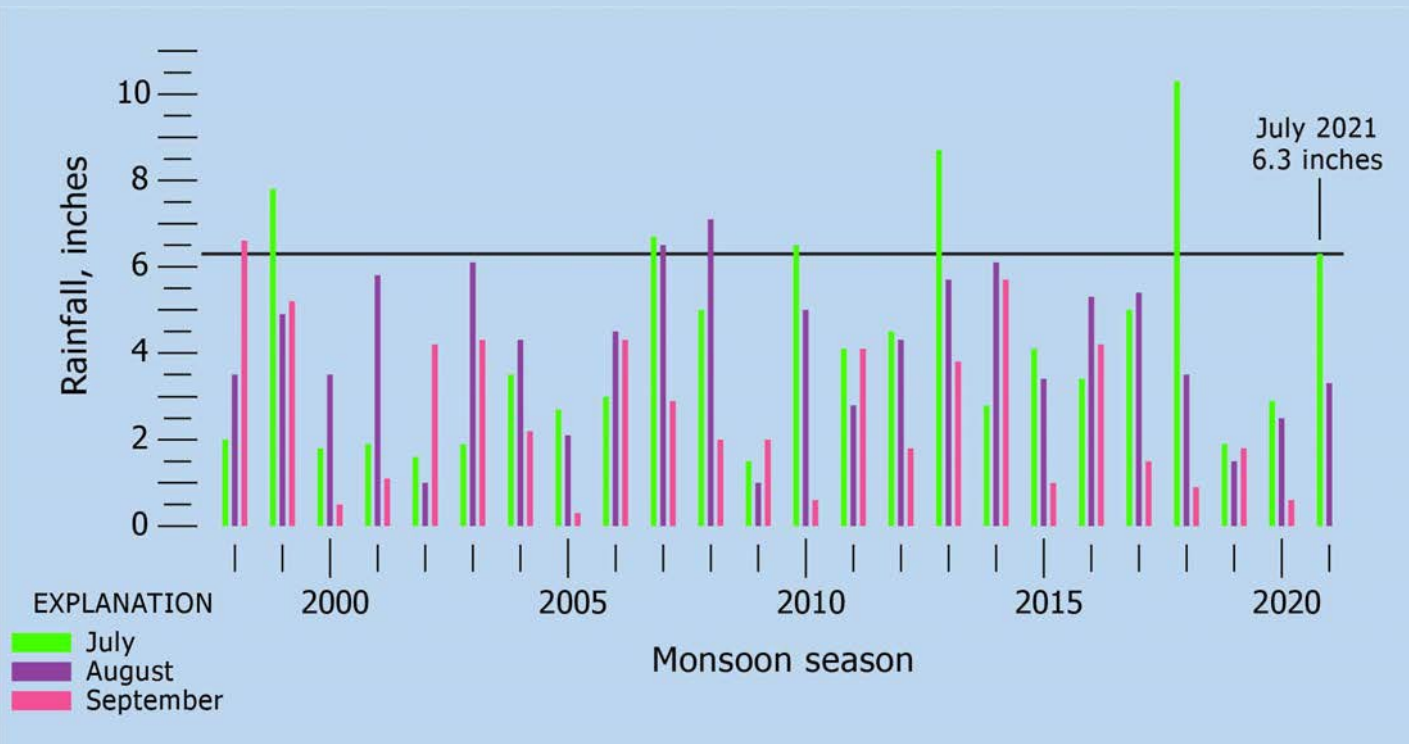
*Bar chart of seasonal monsoon rainfall, 1998–2021. The seasonal total rainfall of the monsoon months, July, August, and September, are color coded.*

We hypothesize that the July 2021 rainfall, although not unusual, is important because it is a fair representation of the amount of rain necessary to produce high-volume runoff. All things being equal, the July runoff-producing rainfall of 6.3 inches is a meaningful threshold.

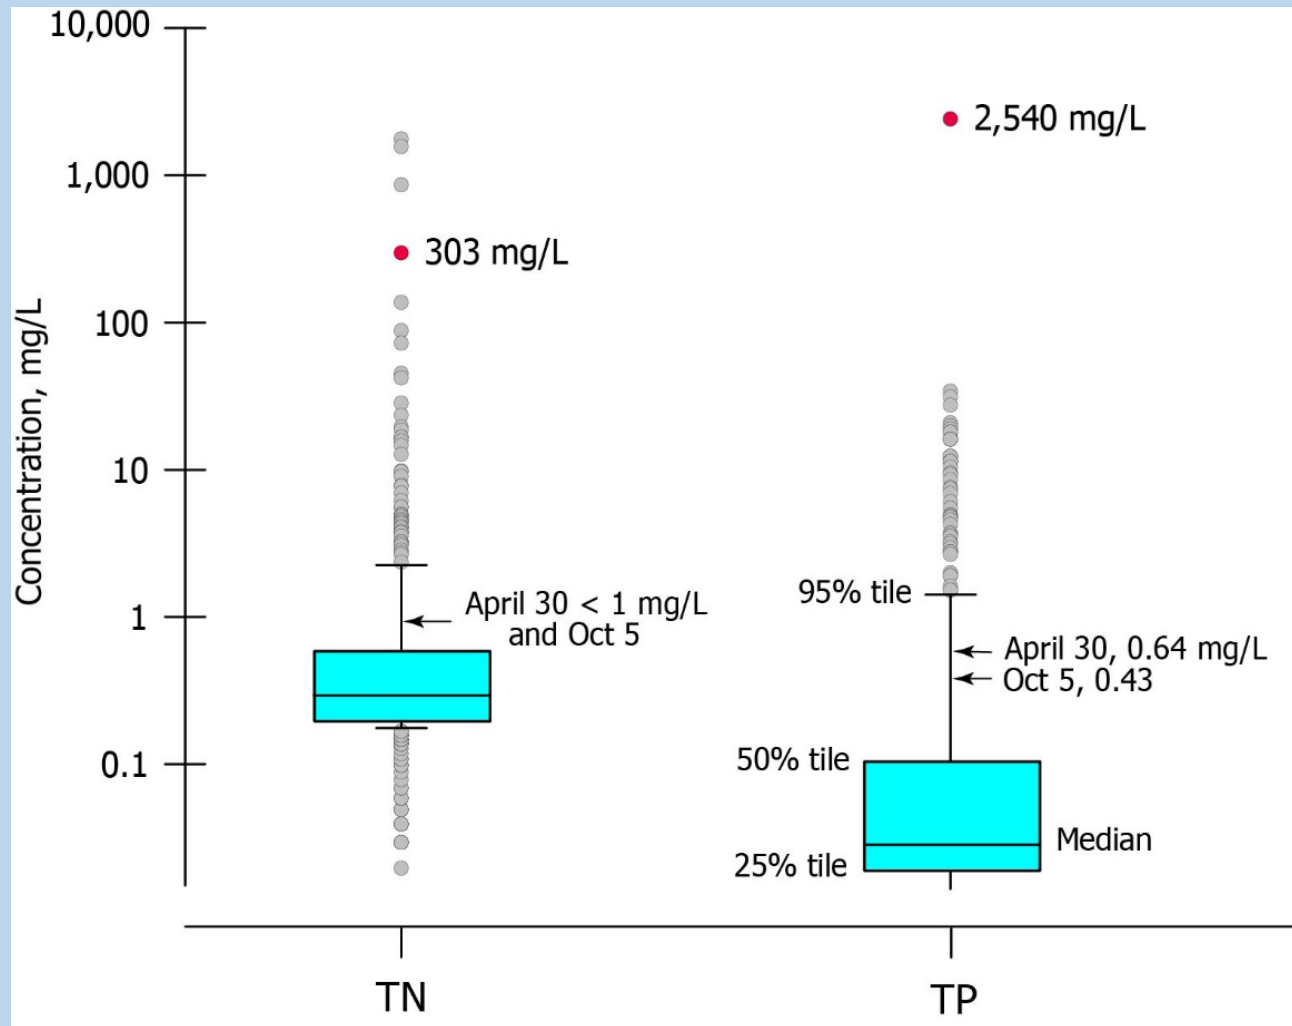
Box plots showing the statistical distribution of total nitrogen (TN) and total phosphorus (TP) compared with flowing surface waters of the Coconino Plateau region (data from Bills and Flynn, 2002).

Samples of the April 30, July 18, and October 5, 2021 runoff events were collected for standard water quality analysis. Red circles are the total nitrogen and phosphorus concentrations, respectively, of the high runoff event of July 18, which had a flow rate of approximately 10 cubic feet per second.

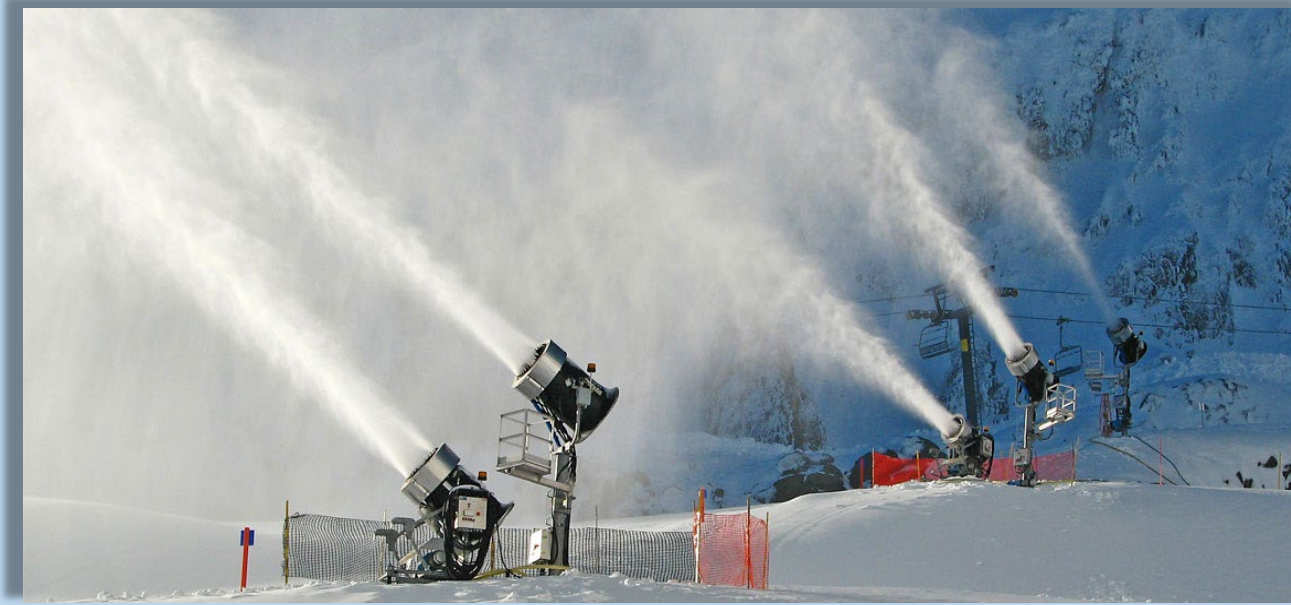
*Snow blowing and snowmaking on an unknown ski slope in the West (Credit: snowmakers.com).*
